Canadian Conference - Pacific Conference on Earthquake Engineering 2023

Performance-based Seismic Analysis for the Retrofit of Pre-code Hospital Building in a Moderate Seismic Region

Guo, Jack^{1*}, Tang, Li Ming², Tapia, Joshua¹

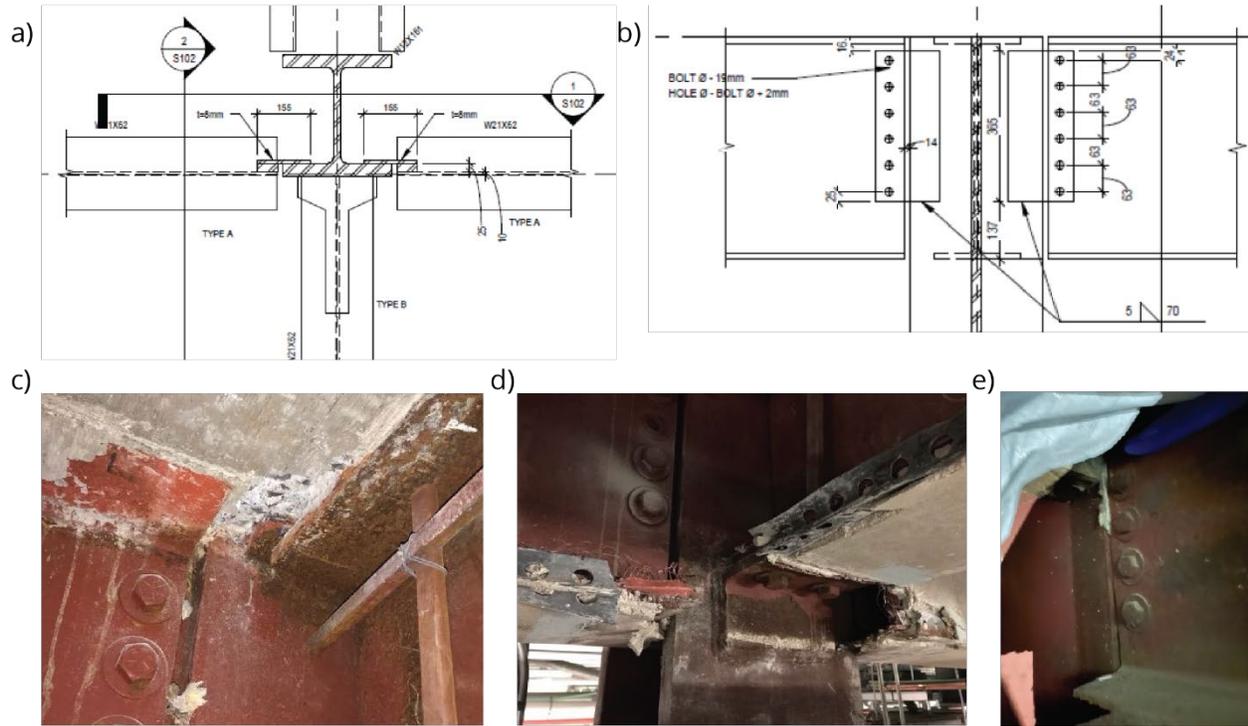
Due to the use of non-conforming connection types by modern code standard, field investigation was required to develop a good understanding of the lateral load resisting system, in particular the beam column connections. Figure 3 shows selected schematic sketches and photos of several variations of the existing beam column connections uncovered during the site visit. Based on the field investigation, most of the connection along the short building axis consists of welded flange cover plate moment connections with a bolted shear tab. The cover plate of these connections is hidden under the concrete slab above, so its dimensions were confirmed using an x-ray scan. Along the long building axis, there are joints where the beam flanges are connected to the web of the columns in the weak column axis. However, most of the connections along this direction are bolted shear tab connections with either a bolted or welded plate to the column, or a welded angle to the web of the column, which does not have much capacity in resisting moment. In some locations, the web is connected to the flange of the column in order to accommodate electrical conduits. Also, a seat angle bolted to the bottom flange can be observed in some connections. However, these are assumed to be angles used for fixing the beams during erection and are not part of the main structural system. According to ASCE-41, the connections along the short building axis is classified as a fully restrained moment connection whereas the shear tab connections are considered partially restrained connections. Note that in all cases, shear studs that couple the beam to the concrete slab above is not confirmed, and hence no composite action is considered. Furthermore, samples of steel coupon from beams, columns and bolts were removed and tested in the lab

Figure 3: Beam column joint sketches and photos a) cover plate flange connection sketch b) typical shear tab connection sketch c) photo of cover plate connection d) photo of shear tab connection with seat angle e) photo of shear tab connection to column flange

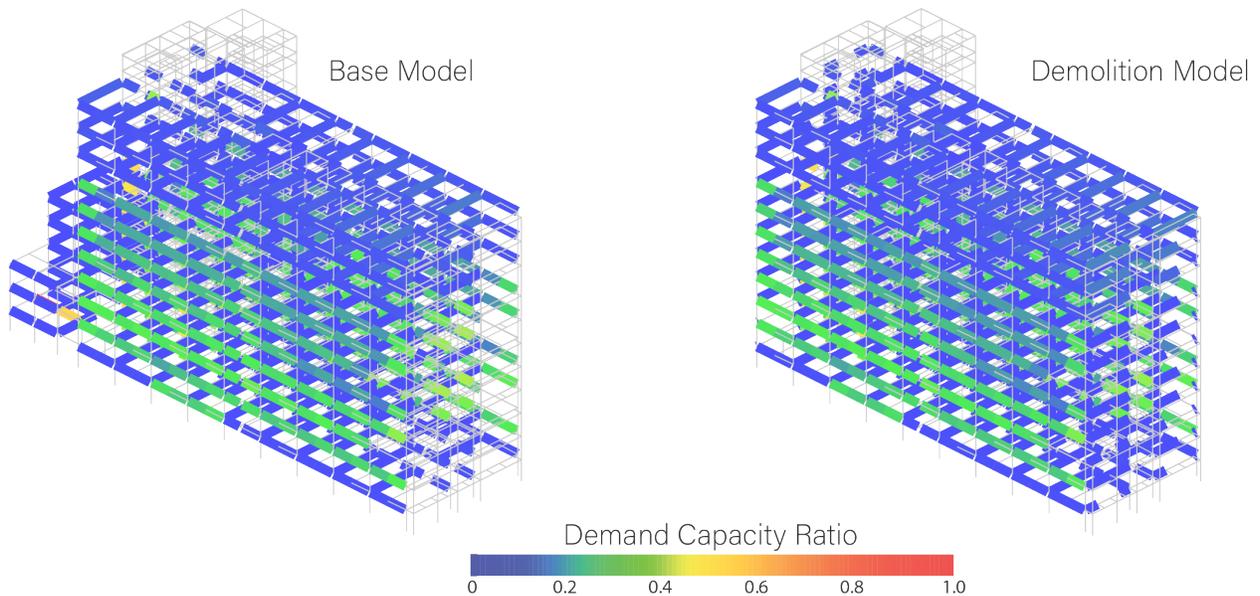
Figure 9 provides a visual summary of the post-processed building result in terms of joint rotation demand capacity ratio (DCR) measured against the ASCE-41 limits for full and partially restrained moment connections. The color of the frame represents the largest of the *i*-th or *j*-th node connection DCR measured against the ASCE-41 LS plastic rotation capacity.

Figure 9: Beam-column joint rotation DCR against LS performance criteria

Similar to the building results presented above, the behaviour of the Base and Demolition buildings are nearly identical, with the vast majority of the element DCR values being within 10%. Furthermore, all joint rotations are less than the ASCE-41 LS limits, with the largest joint rotation reaching about 50% of the limit. Given that many of the joints contribute to the seismic response by allowing small friction slips to dissipate energy, the uncertainty associated with the friction strengths of these joints is a critical aspect that was investigated using a sensitivity analysis where the friction strengths (bolt prestressed force) are varied. For brevity, the results are not presented. While the performance of the building is affected to an extent by the friction in the shear tab joints, these analyses do not change the conclusion above pertaining to the change in behaviour before and after the proposed demolition. Hence, regarding the first goal of the assessment, the nonlinear dynamic analyses did not find evidence that the seismic performance of the building is worsened by the demolition. However, the building is obviously deficient seismically due to its reliance on non-conventionally, and potentially non-reliable mechanisms for lateral resistance. To rectify this, the second part of the assessment is to develop a retrofit scheme that causes minimal disruptions to the hospital operations while meeting stringent operational requirements.

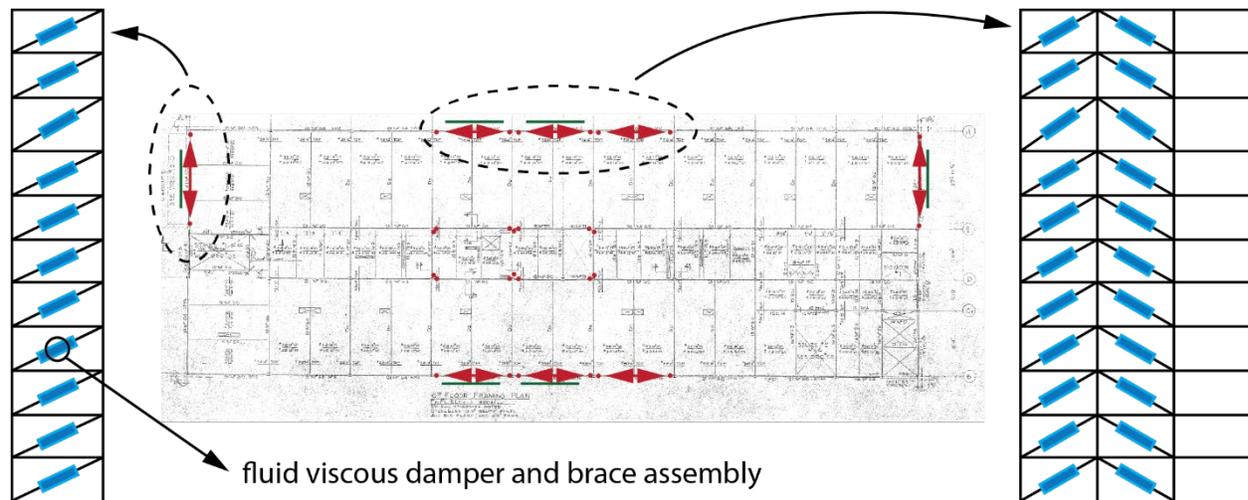
Figure 10: Schematic of proposed seismic retrofit

Since the building was not designed for earthquake forces, a significant increase in stiffness would likely require substantial strengthening of the existing cast-in-place concrete diaphragm, and the foundations. Furthermore, increased stiffness will increase floor accelerations causing further damage to the mechanical, HVAC and architectural components to the building, which were not designed and anchored in accordance with modern seismic standards. From a cost and functional disruption perspective, it was desirable to maintain low stiffness and use passive supplemental damping to control drift and acceleration. A flexible structure also has the added benefit of being dynamically insensitive to the earthquakes in central eastern North America where most of the energy contents concentrate in the high-frequency band, and are short in duration (Atkinson 2009). As a result, a retrofit that involves strengthening of selected exterior joints and adding passive supplemental fluid viscous dampers was proposed. A schematic of the proposed retrofit solution is shown in Figure 10 showing two frames along each direction upgraded to develop full moment capacities of the beams with supplemental fluid viscous dampers. The P-Spectra method (Guo and Christopoulos 2013) was employed to design the dampers, targeting 10% added viscous damping in both building directions. The required damper distribution is expressed in terms of viscous constants per storey, which are summarized in Table 2.

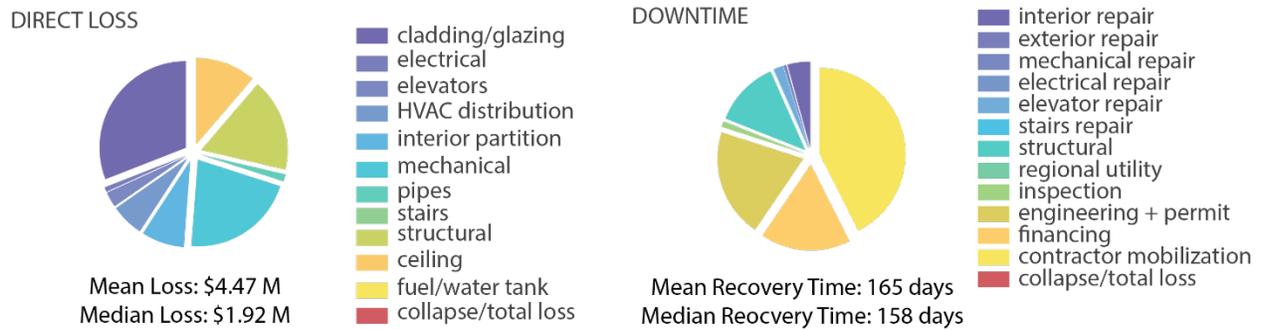
Figure 13 summarizes the loss assessment results in terms of mean and median loss and downtime. Since the analysis considered only the 2% in 50 years event, the annualized loss was not evaluated. The mean direct loss of \$4.47M is less than X% of the replacement cost of the building, and is considered minor. Most of the losses are attributed to exterior terra cotta partition damage, mechanical damage, and structural damage in the steel joints. The mean and median functional recovery times, on the other hand, are on the order of 5 months, which is very significant. As mentioned above, the functional recovery time is assessed using the REDi methodology, and it is widely recognized that several of the assumptions made by the REDi method may not be realistic. One of these assumptions is that the building is not functional unless 100% of its pre-earthquake function has returned. In reality this is not true as reactionary measures put in by tenants and occupants tend to allow a much quicker partial recovery, which are not accounted for in the REDi procedure. However, the bottlenecks to recovery identified in this process are still very useful in informing decision makers the approximate scale of the problem and potential solutions.

Since the goal is to achieve 0 median recovery time, realizations around the median functional recovery of 158 days were further examined to identify specific bottlenecks. These were found to be unbraced terra cotta partition damage, elevator damage, suspended lighting damage, damage in drywall partition and finish (beyond cosmetic), as well as damage to mounted equipment in the mechanical storey including air handling units (AHU), motor control centre, chiller and diesel generator. Some of these elements can be readily remedied using inexpensive details. On the other hand, bottlenecks like elevator damage is extremely difficult to eliminate. However, it is not necessary to fix everything in order to achieve zero median functional recovery since the elimination of each bottleneck will reduce

Figure 13: Summary of loss and recovery time, and component-wise contribution to risk

the probability of failure in all scenarios, not just the median case. A proposed non-structural upgrade scope involving installing out of plane bracing to unbraced terra cotta walls, add independent suspension wires to lighting throughout the building, and isolating the large AHUs, chiller, motor control panel, and the switch gear on the mechanical floor was enough to reduce the median recovery time to zero under the 2% in 50 years event. Note that aside from the terra cotta partition and suspended lighting which are found throughout the building, all other elements are concentrated in the unoccupied mechanical storey. Work here is anticipated to cause minimal disruption to the operations.
