POST-MORTEM INVESTIGATION OF THERMAL DAMAGE IN CARBON/EPOXY COMPOSITE MATERIALS CAUSED BY SIMULATED LIGHTNING STRIKES

G. Zhou¹, A. Ashby¹, J. Golding¹, X. Bao² and W. Sun³

¹Department of Aeronautical and Automotive Engineering, Loughborough University, Leicestershire,
LE11 3TU, UK

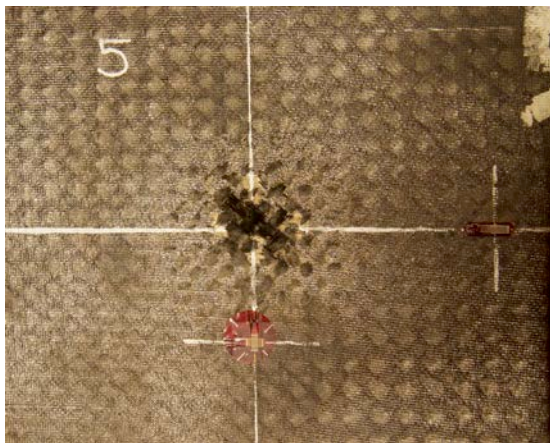
Figure 3. Carbon/epoxy specimen struck by lightning current of 61kA.

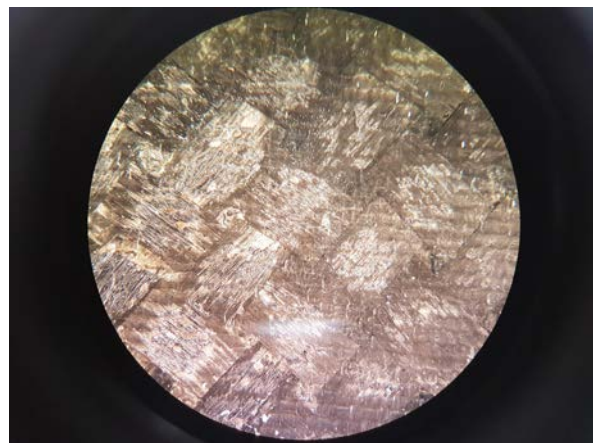
Lightning damage in these laminate specimens was found to cover thermally degraded resin via discolouring, resin sublimation, fibre tufting due to shock waves and tufting-driven delamination. The resin degradation as shown in Fig. 4 ranges from discolouring, fragmented species and soot (invisible), to sublimation, whereas very limited delamination was believed to be induced by the action of fibre tufting. The penetration of the lightning arc into the laminates was found to be limited to the only top three plies in the extreme case, as the lightning strike direction was in the insulative thickness direction so that the attached lightning arc sublimated in only the shallow path of resin in the immediate vicinity

to the surface. Local temperatures within the lightning channel may well have been above 1000^oC, as often speculated [1-2], where resin sublimation, the phase transition, was largely confined.

Figure 4. Resin thermal degradation via discolouring in a lightning struck carbon/epoxy panel.

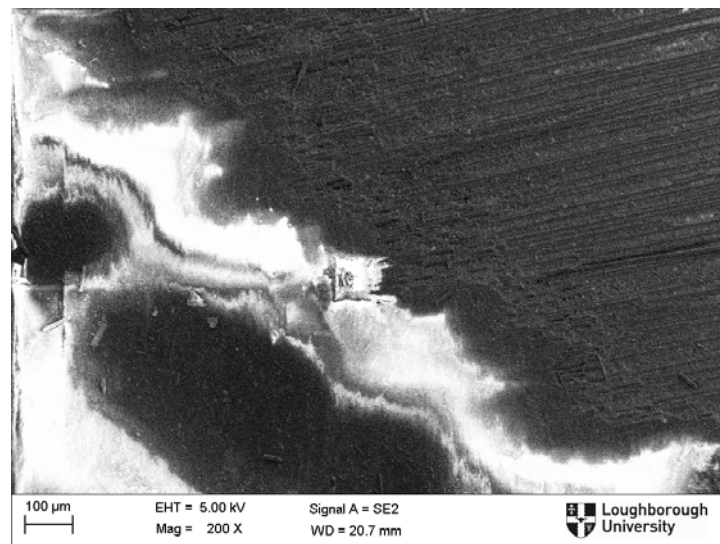
Fig. 5 shows the border region between the remaining discoloured resin (on the left) and the resin sublimated patch (on the upper right) on one of the lightning struck specimens. The exposed individual carbon fibre filaments are visible, when resin on the top ply surface vapourated at the very high temperatures. There was no solid residue observable in the lightning attachment area. A tiny amount of soot could be felt, when one rubbed fingers through the attachment areas.

Figure 5. SEM-EDS image of a thermally degraded area by simulated lightning strike.

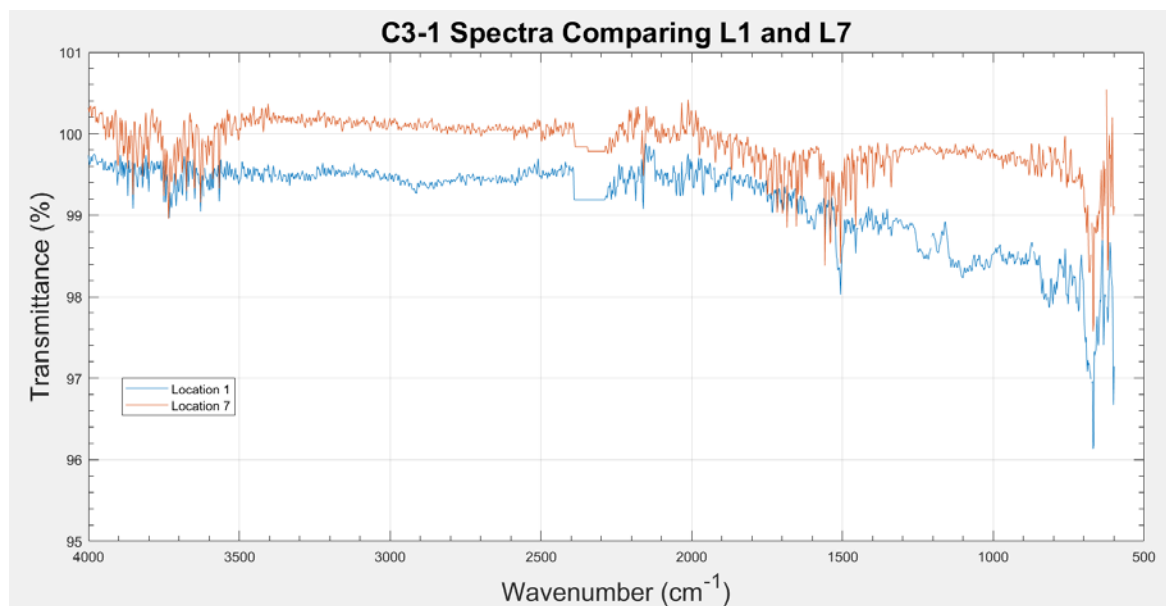
Typical FTIR-ATR infrared spectra in terms of absorbance versus wavenumber are shown in Fig. 6, in which wavenumber normally vary between 4000 and 400 cm^{-1} . A comparison with a common ATR spectrum library of chemical compounds allows the identification of not only the chemical compounds of DGEBA-DDM epoxy system but also specific functional groups. In general, the peak positions with a resolution of 4 or 5 cm^{-1} indicate the structures of the molecules in the sample and the peak intensities indicates the concentrations of molecules in the sample and the peak widths are sensitive to the chemical matrix of the sample. In the figure, it can be observed that the functional group region (from 4000 to 1800 cm^{-1}) shows the significant similarity, whereas the composition region 1800 to 500 cm^{-1} shows the substantial differences from 1400 to 700 cm^{-1} , which reflect the lightning damage.

Figure 6. FTIR-ATR spectra from two different locations of a lightning struck carbon/epoxy panel.

The functional groups found to vary according to the severity of the lightning strike damage include ether link C–O–C around 1150-1070 cm^{-1} , ketone C=O stretch around 1750-1720 cm^{-1} and *p*-phenylene C–C stretch around 850-800 cm^{-1} .

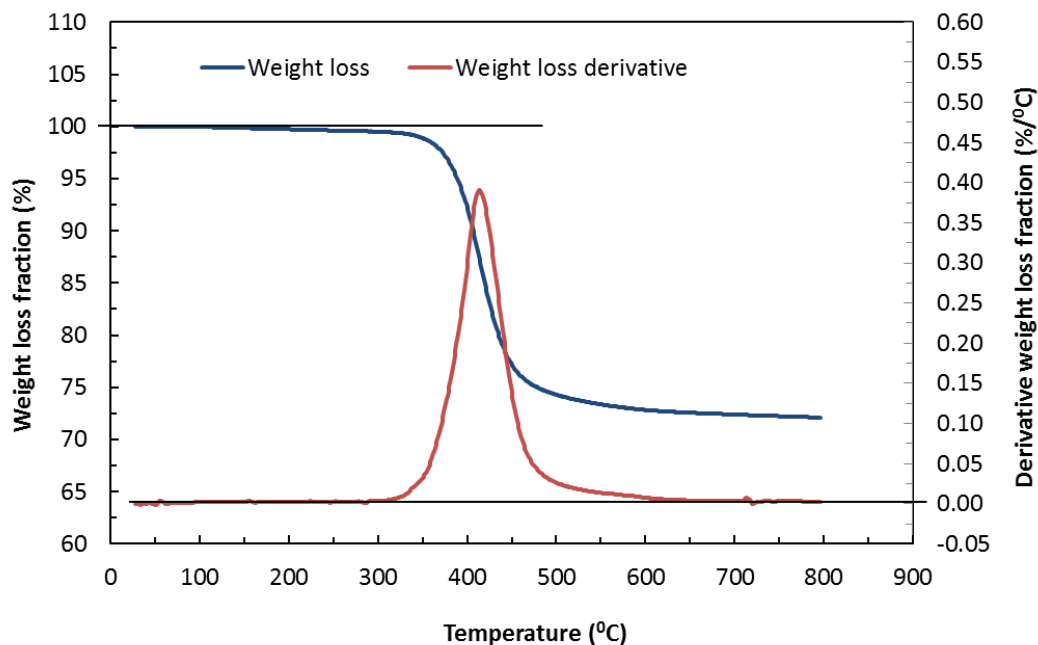
Non-isothermal TGA tests were conducted at four different heating rates from 5^oC/min to 20^oC/min and in both inert environment and air. Typical TGA results in terms of weight loss and derivature weight loss versus temperature are shown in Fig. 8. A comparison of the thermal decomposition performances of the samples from the selected locations was conducted. It was found that the thermal degradation process of the TGA samples was dictated by dehydration characterised by bond scission and ended with sublimation. There is a similarity of qualitative nature between the TGA thermal decomposition process and the thermal degradation and sublimation process at the centre of the lightning attachment area. The average values of activation energy for the DGEBA-DDM LTM45 epoxy system were found to be 61.5 kJ/mol using the Kissinger method and 64.8 kJ/mol using the OFW method. These values are close to 58.3 kJ/mol from [5] for the Kissinger method. Similarly, our value 64.8 kJ/mol for the OFW method is very close to 62.9 kJ/mol from [5].

Figure 8. TGA test results of a carbon/epoxy sample with a heating rate of 20⁰C/min.
