APGA INFORMATION PAPER

Making pipelines piggable in the 21st century

Document No		N/A		
Rev	Date	Status	Originated	Checked
0	21/09/22	For Information Only		
			Colin Yeoh	Matthew Clarke
			Team Lead Projects	Team Lead Integrity

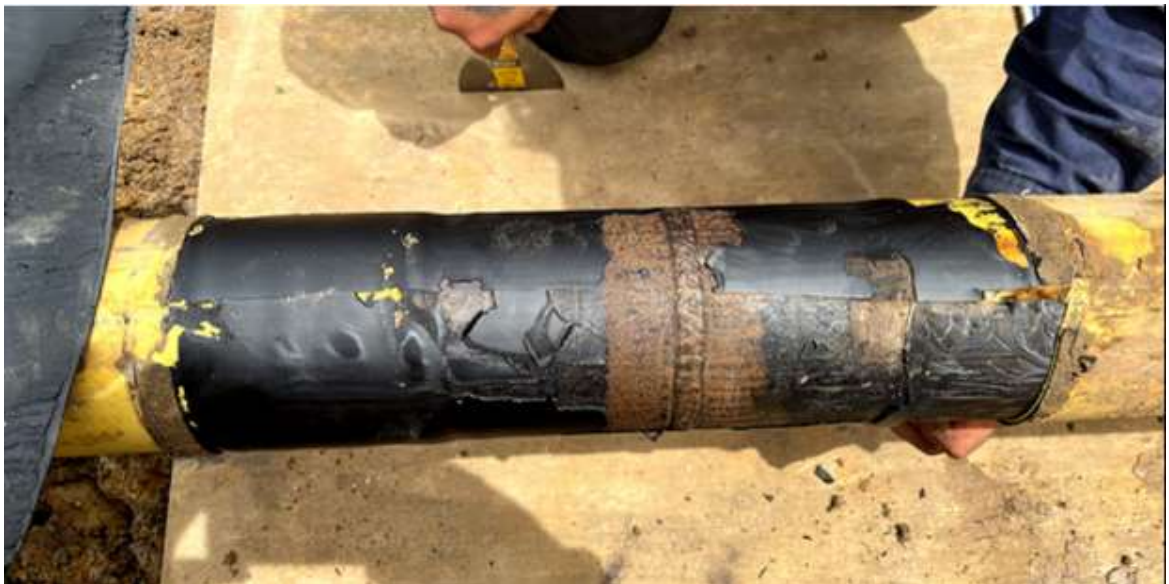
Inspection of the T64 located numerous milling anomalies, no dents, and two external corrosion clusters associated with failed heat shrink sleeves.

The deepest corrosion feature was 15% of nominal wall. These will be excavated within the next 12 months however the excavations will be challenging due to access and potentially contained soils in the area.

Demonstrating the integrity of this pipeline using External Corrosion Direct Assessment methods (DCVG) is likely to have required significantly more excavation locations, and is unlikely to have been effective in locating shielding corrosion features such as this (Photo below is an example from a different pipeline).

The inspection has provided confidence that the pipeline can continue to be operated safely and the integrity program will continue to monitor the condition of heat shrink sleeves.
