ASSESSMENT OF FAILURE MODES IN COMPRESSION LOADED LAMINATES USING QUASI IN SITU COMPUTERIZED TOMOGRAPHY SCANS.

Jonas J. A. D'haen¹, S. Kerschler¹, M. May², S. Hiermaier²

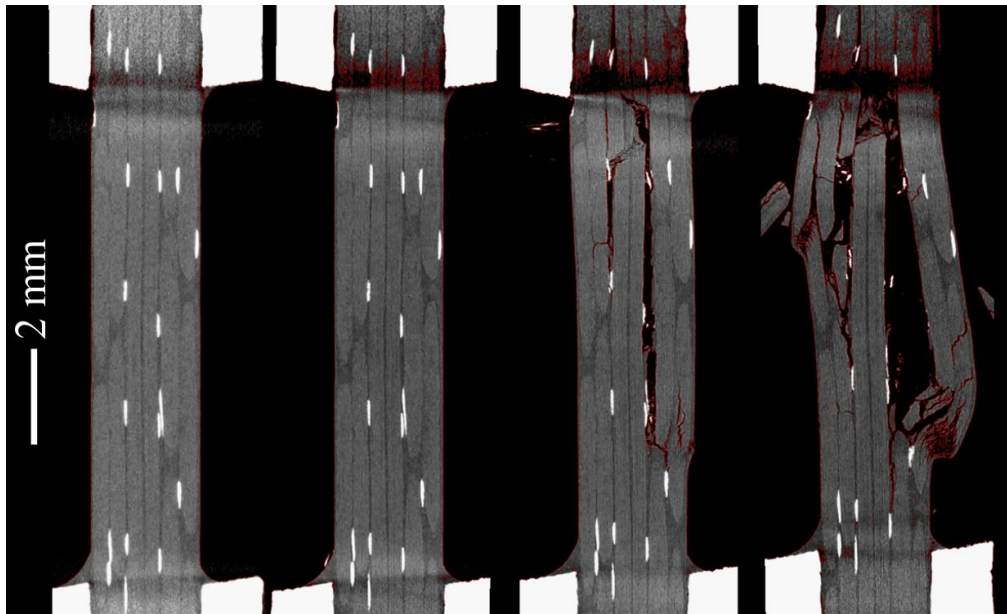
Figure 3. Cross section trough the width of an $0^\circ [45,-45,0]_s$ laminate. F.l.t.r. Reference measurement, point 1, point 2, point 3.

The white vertical lines visible in the CT scan figures are glass fiber bundles in the material to enhance handling during production. The white pieces on the top and bottom of the specimen are the glass fiber tabs used as force introduction. The third specimen, point 2, shows fiber kinking at the top side of the middle two layers and delamination between layer two and three & four and five. Point 3 shows the same failure modes as point 2 plus a pop up delamination in layer five and six. Furthermore, shear failure is seen observed in layer one, two, five and six. The complete list of failure modes is shown in table 2.

Point	Failure modes
Point 1	--
Point 2	Kinking (3,4), Compressive fiber failure (3,4), Fiber/matrix debonding (3,4), Delamination (2-3, 4-5), Shear failure (1,2,5,6)
Point 3	Kinking (3,4) Multi Compressive fiber failure (3,4), Fiber/matrix debonding (3,4) Pop-up delamination(2-3, 4-5) Buckling (1-2,5-6) Shear failure (1,2,5,6)

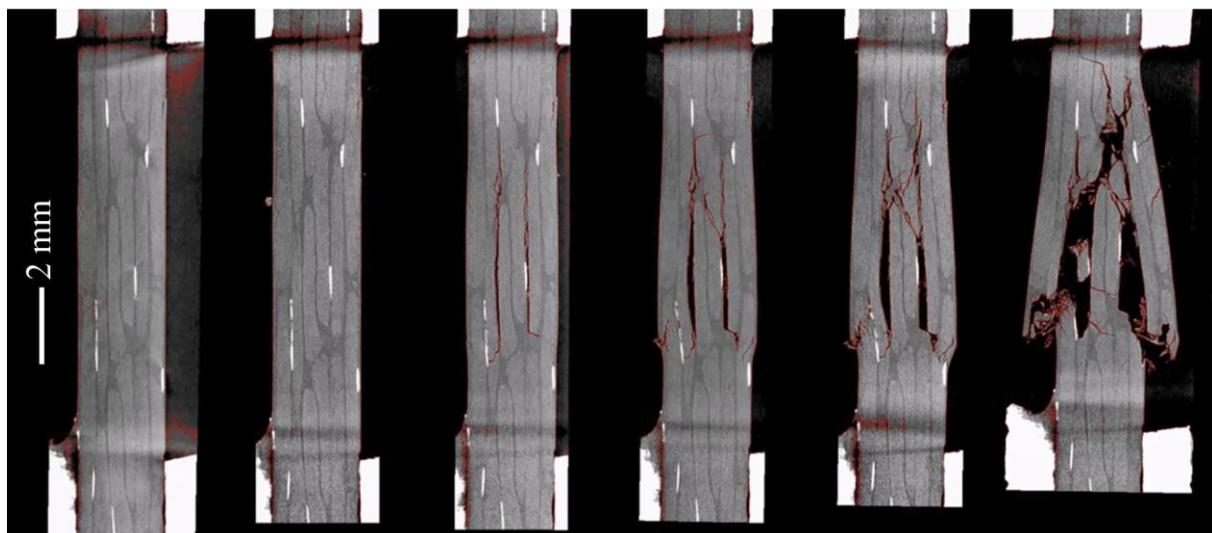
Figure 5. Cross section trough the width of an $0^\circ [45,-45,0]_s$ laminate. F.l.t.r. Reference measurement, point 1, point 2, point 3, point 4, point 5.

The results from the CT scan in 90° direction are shown in figure 5, it can be seen that the failure evolution occurs in a more controlled way compared to the 0° variant. Initial failure in point 2 shows delamination between layer two and three. For point 3 an additional shear failure occurs in the two middle layers. Additionally shear failure is seen in layers one, two, five and six for point 4, whereas complete failure is seen in point 5. Table 4 Lists all the failure modes that have been observed in the

Point	Failure modes
Point 1	--
Point 2	Delamination (2-3,4-5) , Shear failure (2,5), Kinking + shear failure (1,6)
Point 3	Delamination (2-3,4-5) , Shear failure (3-4) , Shear failure (1,2,5,6) Kinking + shear failure (1,6)
Point 4	Delamination (2-3,4-5) , Shear failure (3-4) , Shear failure (1,2,5,6), Kinking + shear failure (1,6)
Point 5	Delamination (2-3,4-5), Shear failure (3-4) , Shear failure (1,2,5,6)
