TRANSPORTATION 2022 CONFERENCE
‘FIX CRASH CORNER’ – A ROUNDABOUT STORY
THIS PAPER HAS BEEN PEER REVIEWED

This is a story about a project with big crash beginnings, fast-track design, effective project management, and ‘Safe System’ endings.

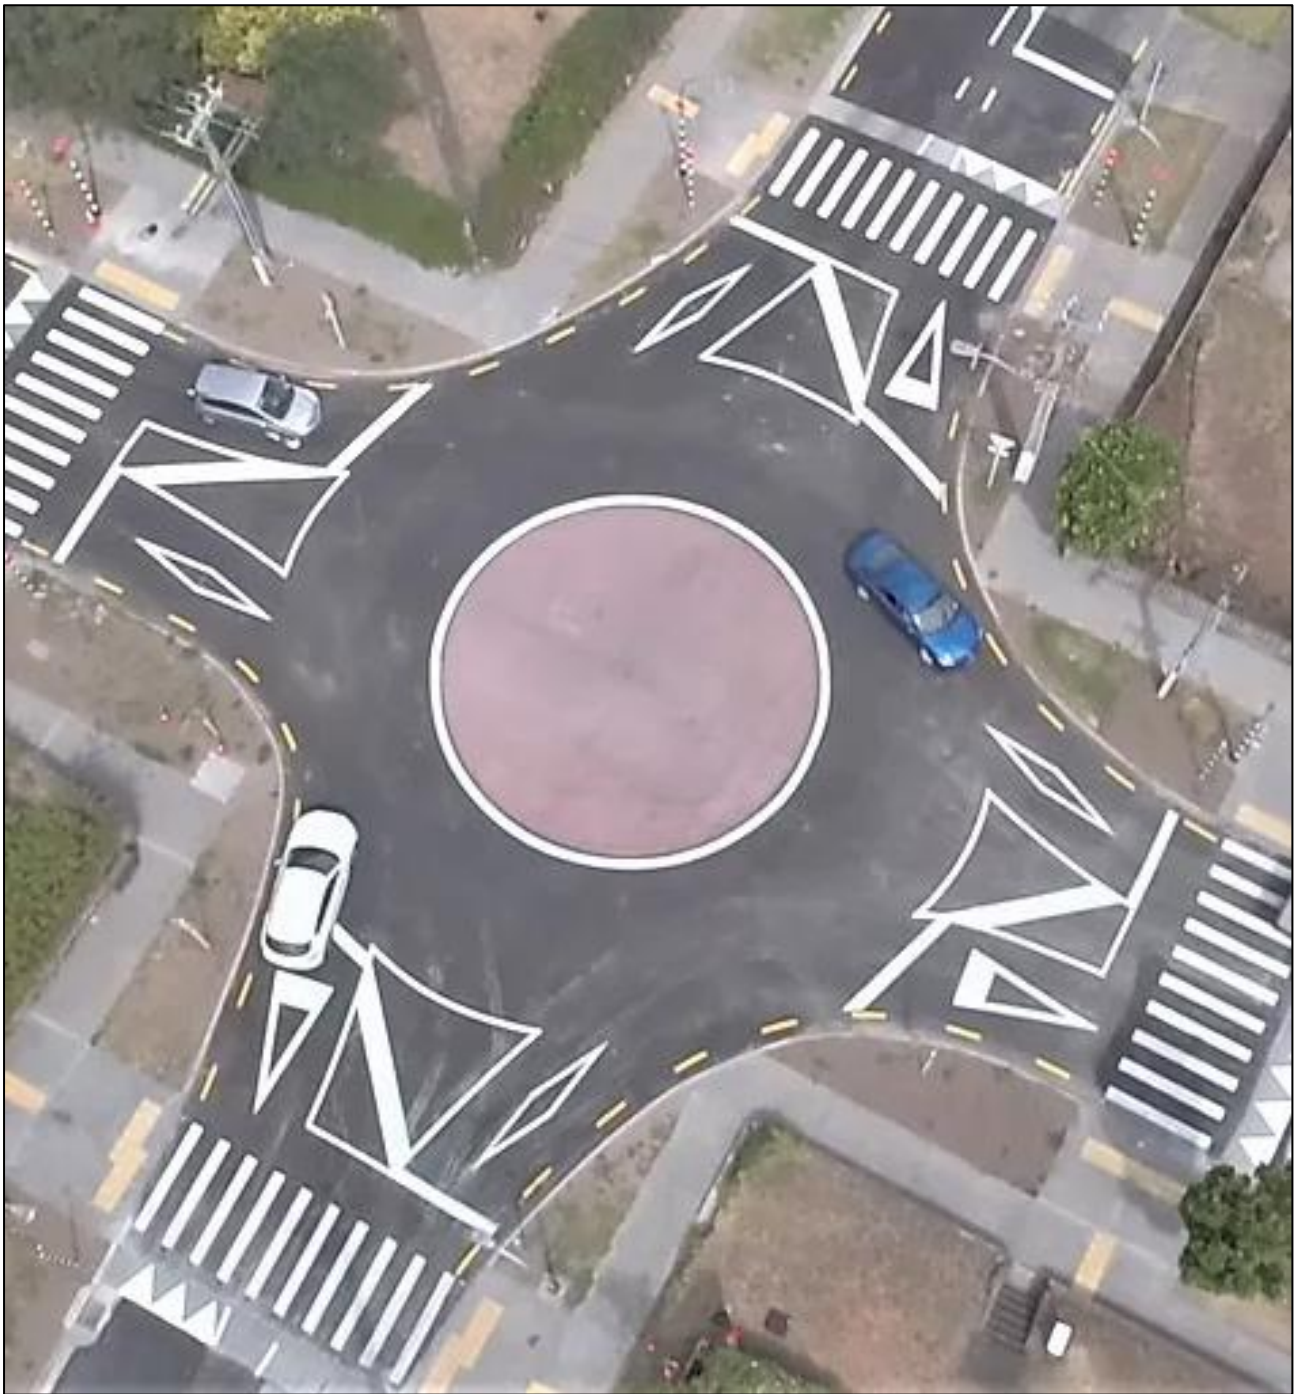
FIGURE 1: NEW ROUNDABOUT

The constructed roundabout was the first ‘Safe Systems – Vision Zero’ design of its kind in New Zealand, being a fully raised roundabout with 4 pedestrian crossings.

As a result of a tight, collaborative team effort the project went from scheme to construction completed in 6 months. It is understood to be the first ‘*Safe Systems*’ design of its kind in New Zealand, being the first fully raised roundabout with 4 pedestrian priority legs.

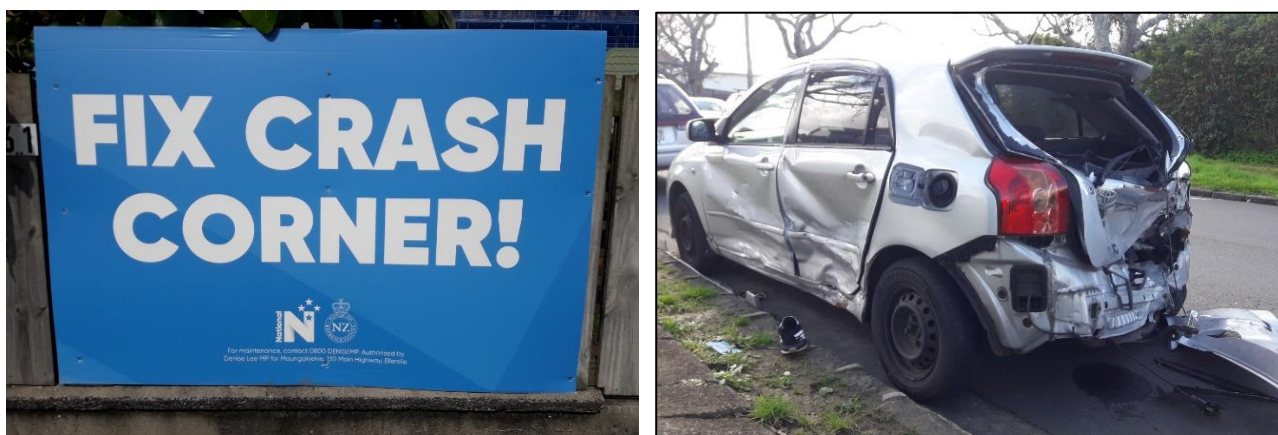
FIGURE 2: FIX CRASH CORNER SIGN, AND NEARBY VEHICLE DEBRIS

The intersection of Church Street and Victoria Street was a cross-roads junction in Onehunga, Auckland, and nicknamed ‘*crash corner*’ by locals. Over the previous 5 years, 54 crashes had been reported at the junction, including 23 minor injury crashes and 1 serious injury crash (DSI). Vehicle debris and property damage were a permanent feature on most corners of the junction.

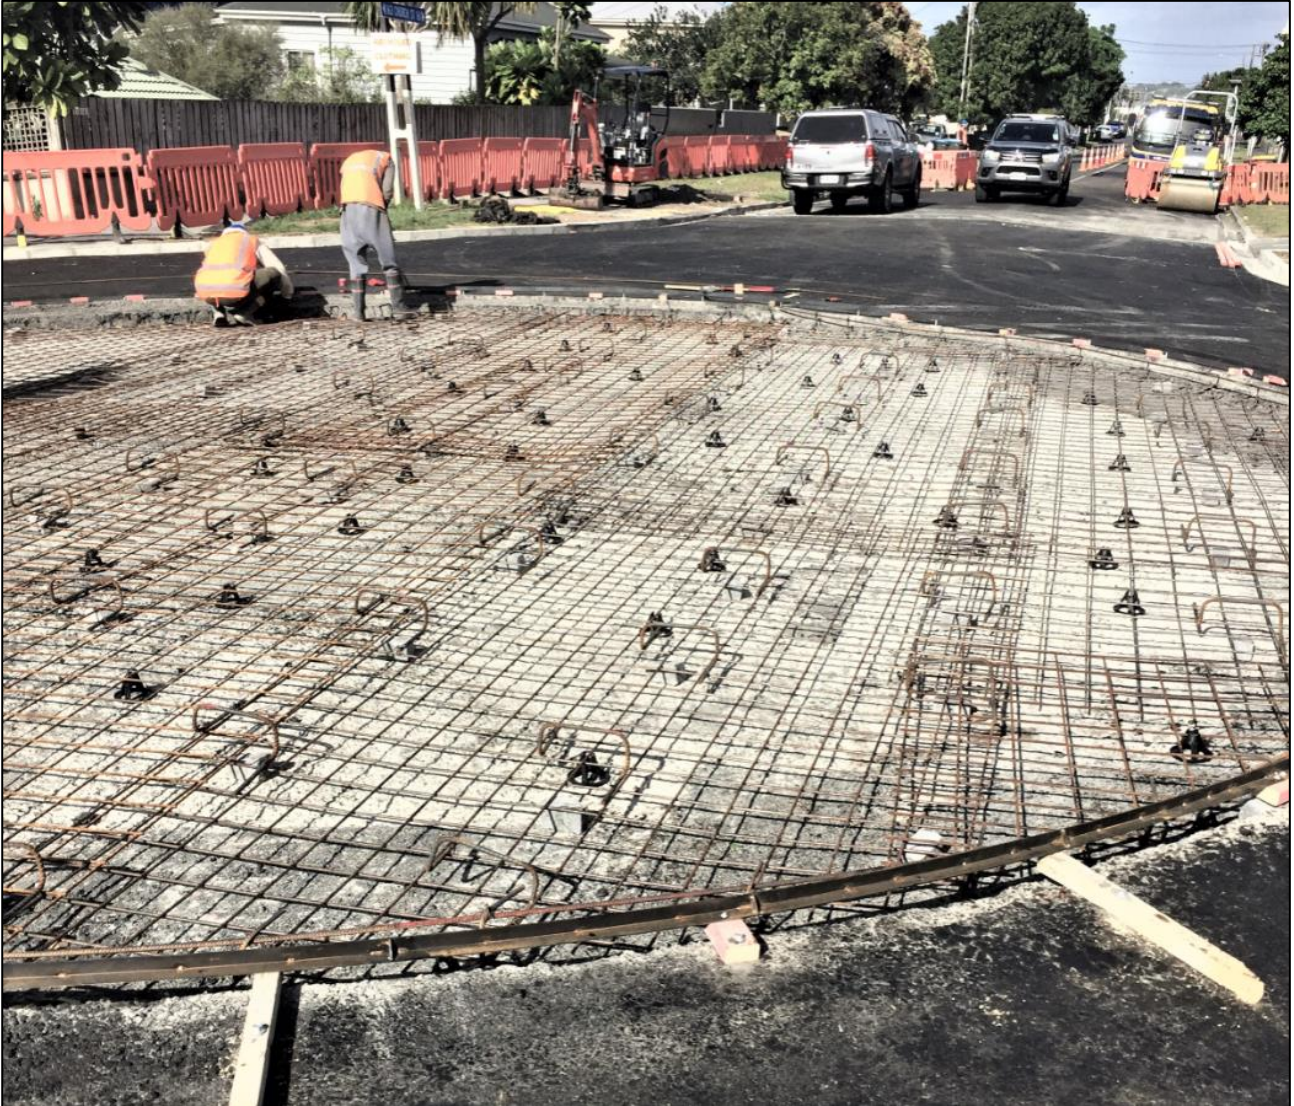
FIGURE 4: FULL TRAFFIC CLOSURE - ROUNDABOUT ISLAND CONSTRUCTION

In order to reduce the time to install the roundabout and ramps and 'cure' the concrete, and asphalt pave the intersection approaches, the project utilised a full road closure with detours, so that full width concrete pours could be implemented for increased structural integrity of the concrete.

Construction was planned in 3 phases; with enabling works (footpaths, tactiles, berm, streetlighting prep, investigations) planned for 2 halves, northern and southern sections, followed by a full closure for the final works over the Christmas break.

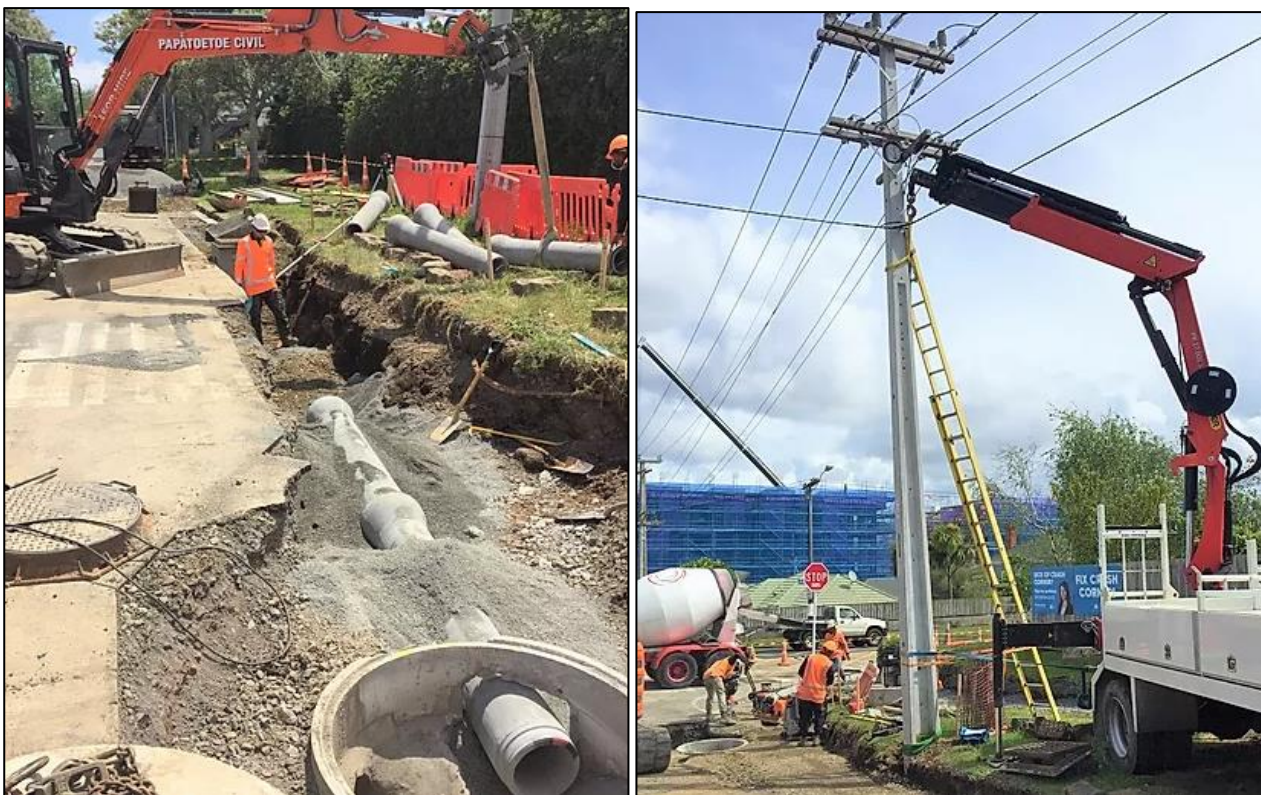
FIGURE 5: STORM WATER WORKS

Recycled water trucks were used on site, and the planning of material sourcing as near to site as possible to reduce the number of trips by contractors (reducing carbon emissions). The stormwater system was protected during construction through the use of silt socks on existing catchpits, and as there is a very steep flow down Victoria Street, these were doubled around the downhill catchpits.

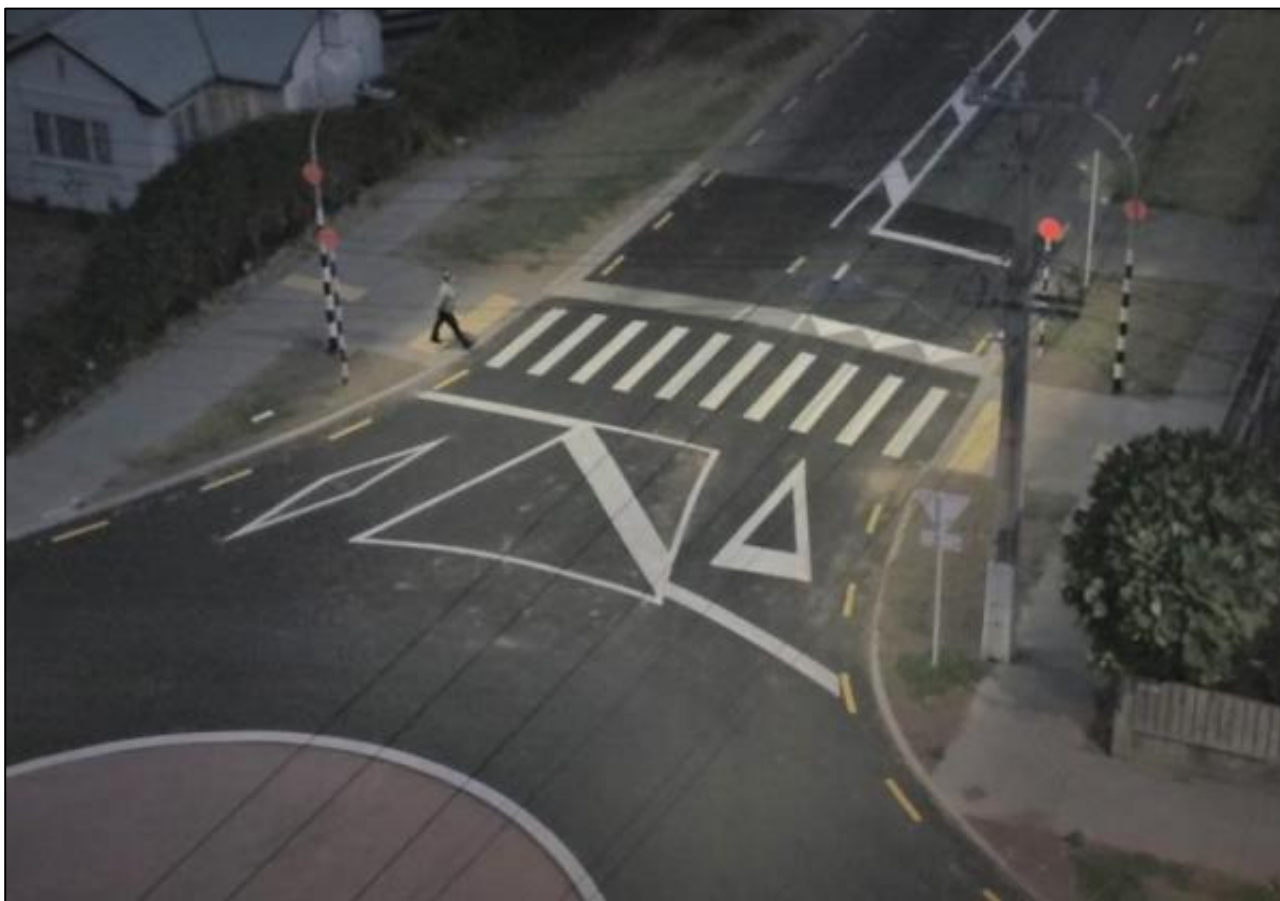
FIGURE 7: NEW PEDESTRIAN CROSSING WITH STREET LIGHTING

Lighting at the intersection was also analysed and was improved at all pedestrian crossing legs, and extra lighting was designed and installed for the intersection and approaches. Due to the proximity of nearby powerlines, the lighting design was complicated and needed to be adjusted to suit powerline spacing requirements.

As an additional road safety improvements, High Friction Surfacing was also proposed to be included as part of the upgrade, to improve pedestrian safety at the pedestrian crossings on all approaches.

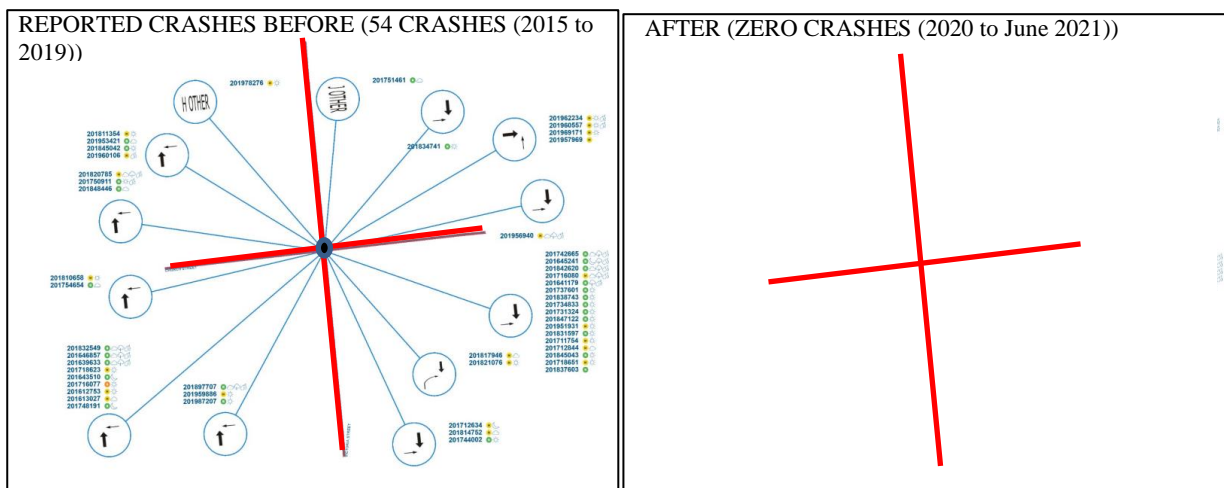
FIGURE 8: REPORTED CRASHES 'BEFORE' AND 'AFTER'

At the previously existing cross-roads intersection, before the roundabout was installed, 54 crashes were reported over 5 years (11 reported crashes per year in a 50m vicinity of the roundabout). These reported crashes included 1 serious injury crash and 23 minor injury crashes.

Since installation, independent crash analysis has determined that there were **ZERO** crashes reported at the roundabout, over an 18 month period since construction.

Indeed, chi-squared analysis indicates an approximate 99.9% probability that the 'intervention' had a significant effect on reported crashes at the junction.
