## Primus Line Company Introduction

# Components of the Primus Line System

# Rehabilitation of an asbestos cement trunk water main with a length of 10 kilometres

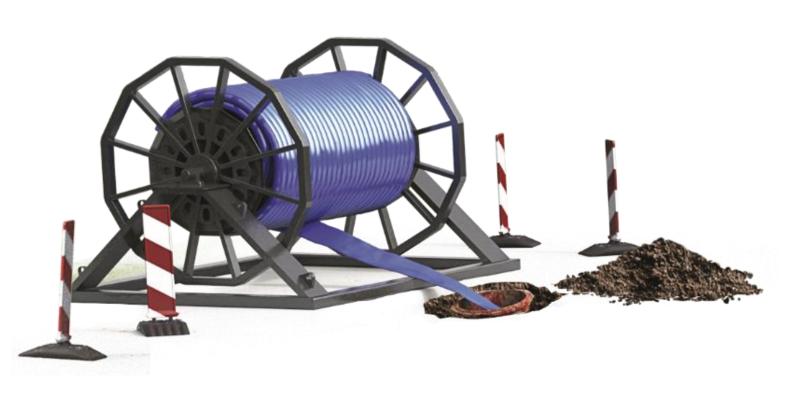
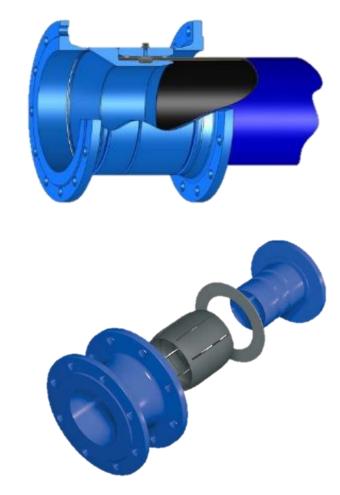
Flexible High-Pressure Liner

Patented End Fittings

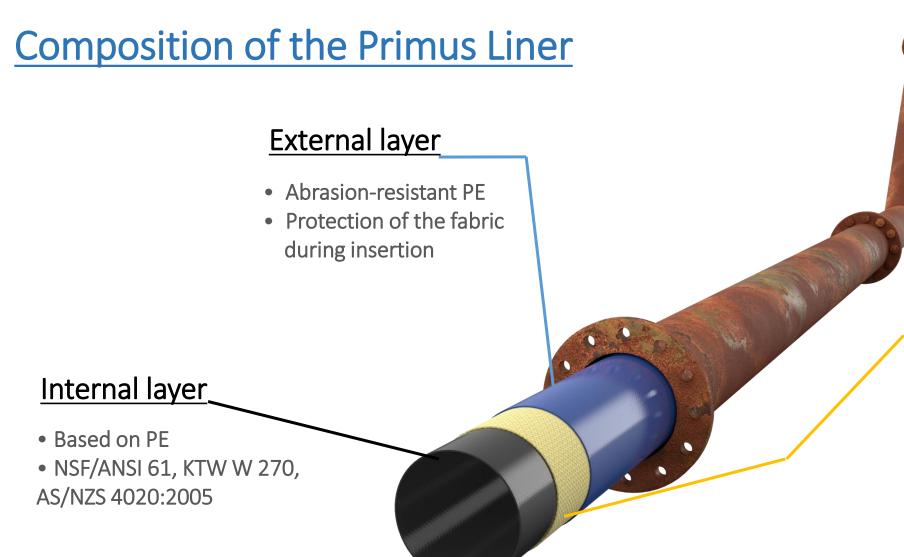
#### **Aramid fabric**

- Accommodates the operating pressure independently from host pipe
- Wall thickness of 6 mm
- Liner is not glued to host pipe (no steaming or curing processes)
- Installed with annulus space

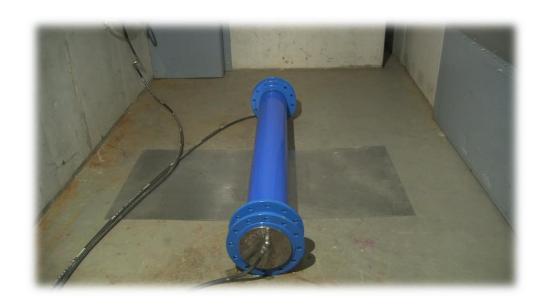
- ➤ Testing basis VP 643, June 2004 Flexible, fabric-reinforced plastic inliners and corresponding connectors
- ➤ Verification of long-term strength according to DIN 16887 and DIN EN ISO 9080 in a series of up to 10,000 hour tests extrapolated to 50 years derived a fabric factor of 2.0
- ➤ An additional safety factor of 1.25 is included

Example DN 200-MD*							
<ul><li>Burst pressure</li></ul>	100 bar						
<ul><li>Lifetime factor</li></ul>	<ul><li>↓ /2</li><li>50 bar</li><li>↓ /1.25</li></ul>						
<ul> <li>Safety factor water</li> </ul>	40 bar

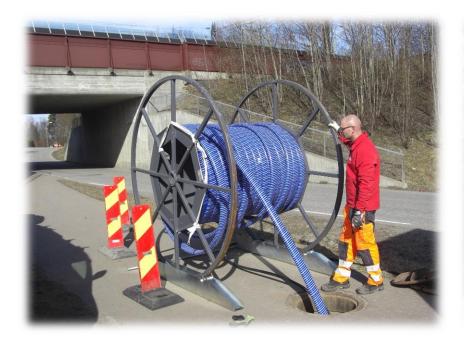
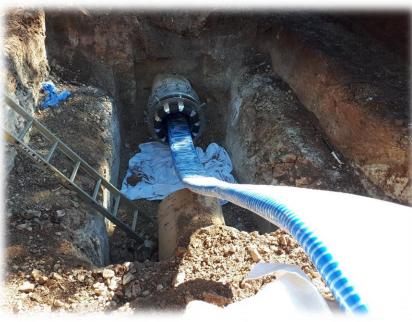
#### Start-pit

Pipe diameter	Working space					
DN 150 – DN 200	min. 1.25 m					
DN 250 – DN 500	min. 1.75 m

- Pipe cut in a 90 degree angle to pipe axis
- Pipe ID to be deburred and chambered
- Use of insertion roll to protect liner

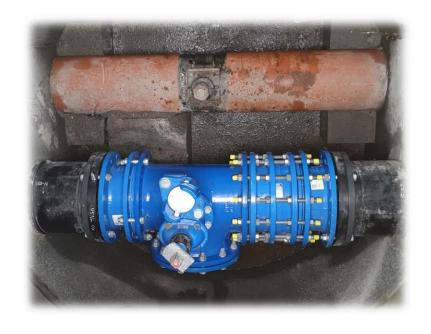
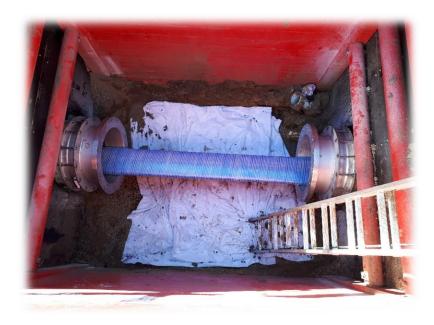
#### Intra-pit

Pipe diameter	Working space					
DN 150 – DN 200	min. 1.50 m					
DN 250 – DN 500	min. 2.00 m

- Pipe cut in a 90 degree angle to pipe axis
- Pipe ID to be deburred and chambered

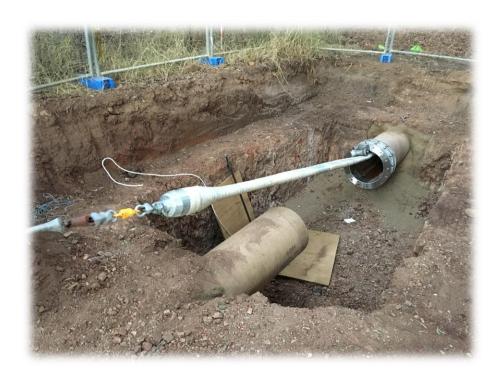
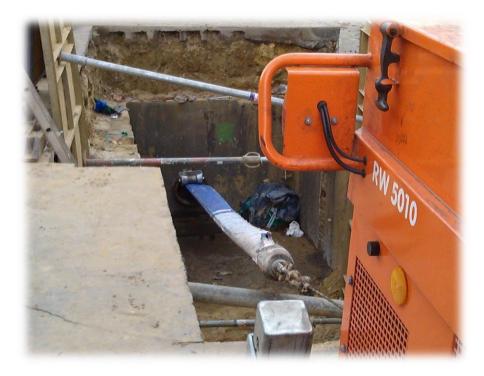
### **Destination pit**

Pipe diameter	Working space	Pulling force	Exit angle			
DN 150 – DN 200	min. 1.25 m	< 3 tons	max. 30 degree			
DN 250 – DN 500	min. 1.75 m	> 3 tons	max. 10 degree

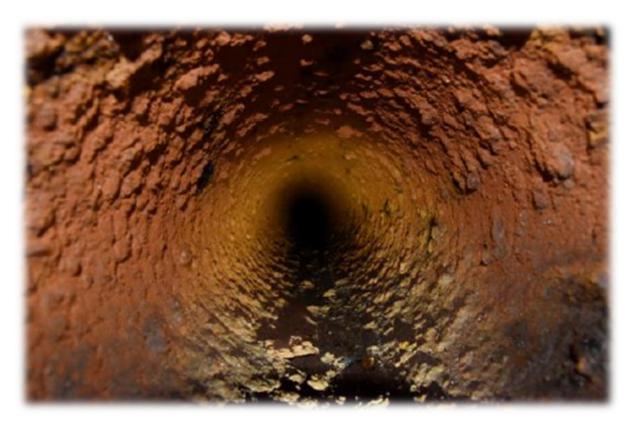
#### **CCTV** inspection goal:

→ Determine cleaning needs

- Focus on reductions in cross-section caused by protruding obstacles (weld seams, fittings, pins)
- > Bends
- > Steps
- > 360 degree inspection of pipe joints
- CCTV used as a means to create the inital rope connection between pits

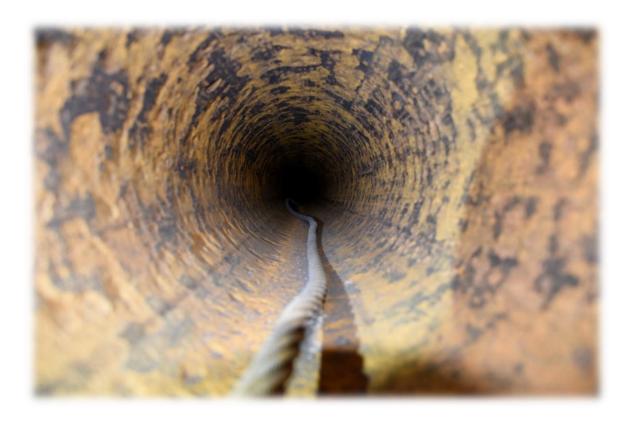
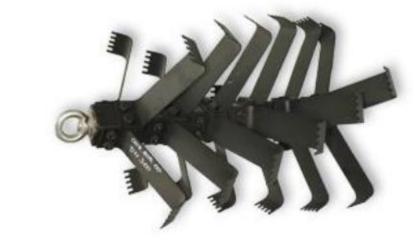
#### Goal: Create a free inside diameter

- > Cleaning requirements dependent on host pipe material
- > Subsequent CCTV inspection to verify free inside diameter

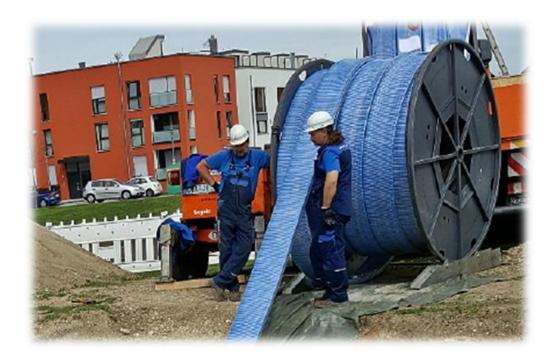
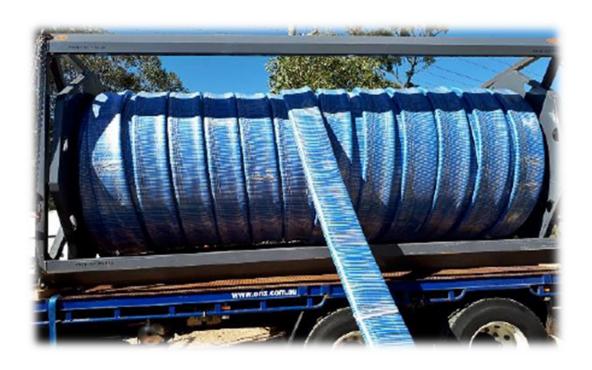
#### **Drum capacities**

Diameter	Reel capacity
DN 150	up to 5,700 m
DN 500	up to 1,675 m

- $\rightarrow$  Width: 1.40 m 11.00 m
- > Suitable for 20ft. and 40ft. Containers
- > Smaller reels via airfreight possible

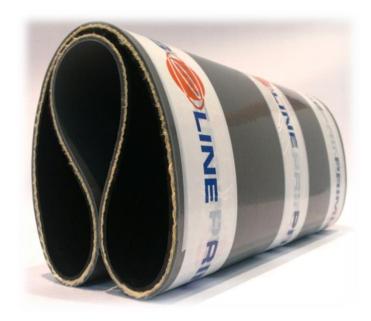
### <u>Liner pre-folded in</u> <u>U-shape at factory</u>

Reduce pulling forces to achieve long insertion lengths

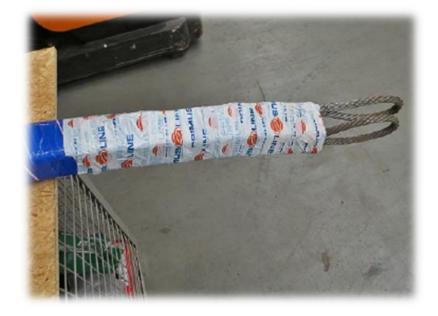
Pulling forces up to 5 tons depending on reinforcement layer

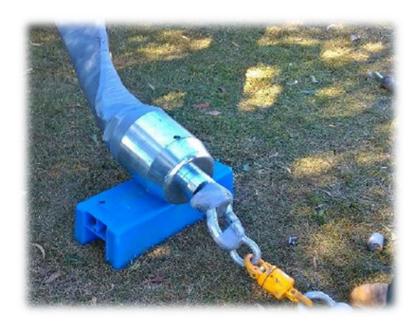
Pulling forces up to 10 tons depending on reinforcement layer

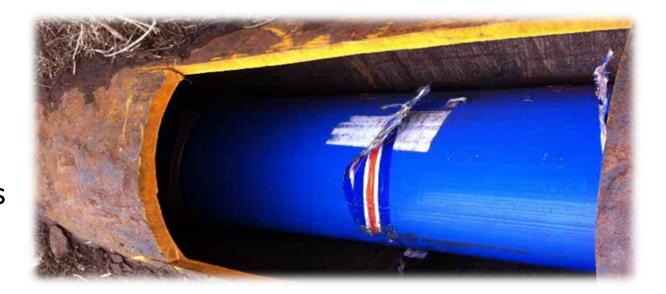
#### Inflation process with compressed air

- ➤ Oil-free air for potable water
- ➤ Pipe stopper to close liner
- ➤ Pipe stopper with by-pass to inflate
- ➤ No heating, steaming, curing processes

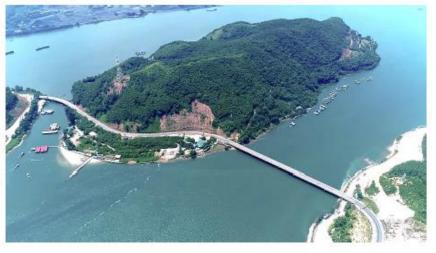
Material of host pipe Steel, unlined Transported fluid Potable water

Diameter of Host Pipe DN 300
Operating Pressure 6 bar

Primus Line System DN 300 PN 12

#### Rehabilitation of DN 300 water pipes at Van Don bridge
