## Ariane 5 Fairing Preparations for James Webb Space Telescope (JWST) Launch

The Ariane 5 fairing for the James Webb Space Telescope (JWST) was inspected, cleaned, and maintained to specified cleanliness requirements to ensure launch distribution of contamination was minimal. NASA, ESA, and RUAG representatives collaborated to inspect and clean the fairing at RUAG facilities and at the launch site. These efforts allowed JWST to meet contamination mission cleanliness requirements and enhance mission observation performance.

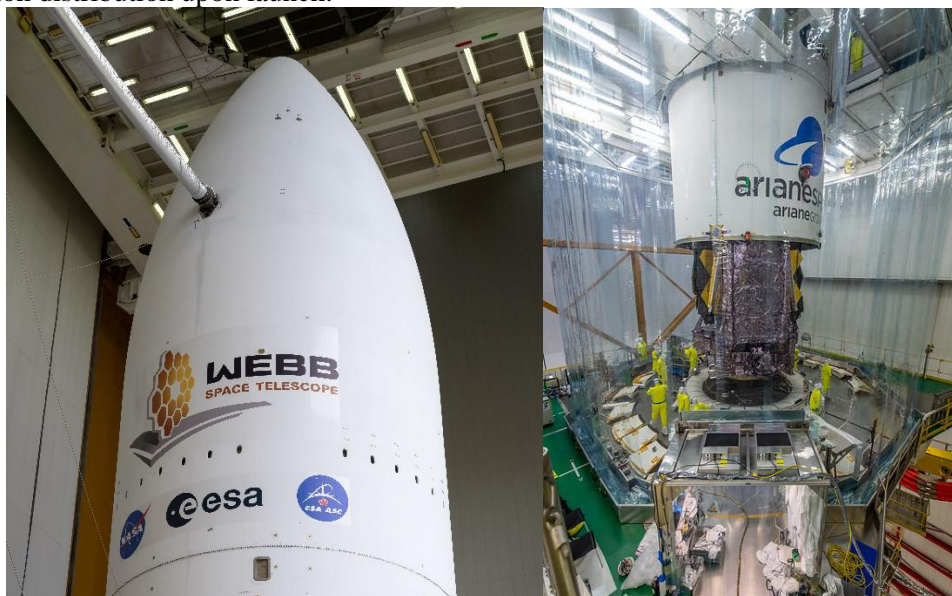
Fig. 1: Ariane 5 fairing (left) and fairing encapsulation (right) within air shower curtain (ASHC).

The James Webb Space Telescope (JWST) is a large, infrared space telescope operating at Lagrange point 2. JWST is a joint effort between NASA, ESA, and CSA and was launched from the Centre Spatial Guyanais (CSG) on an Ariane 5 rocket in December 2021. The Ariane 5 payload fairing (PLF), as shown in Figure 1, interior and Vehicle Equipment Bay membranes received multiple cleanings, detailed inspections, and verification sampling to achieve necessary cleanliness levels.
