# Corrosion in amine pilot plants

4<sup>th</sup> Post Combustion Capture Conference

Kent B. Fischer, Shyam S. Sharma, Gary T. Rochelle

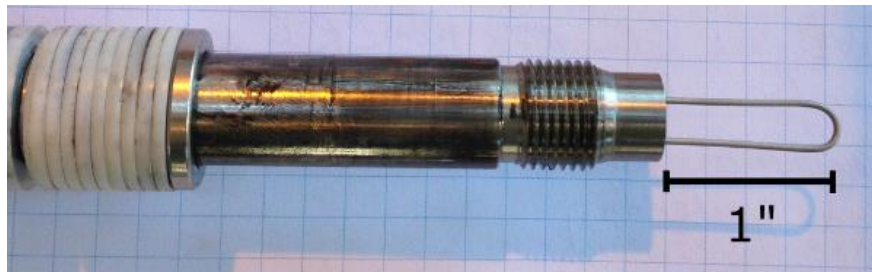
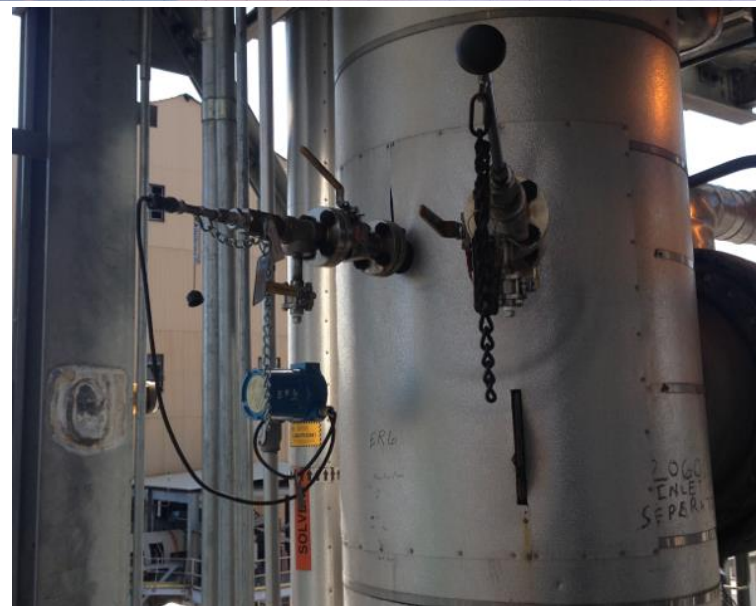
# Electrical resistance corrosion probe

- Sacrificial wire in amine solution corrodes

$$R \propto \frac{1}{A}$$

- R = resistance ( $\Omega$ )
- A = wire cross sec. area
- Resistance  $\uparrow$ , current  $\downarrow$ , measure current and convert to corr. rate

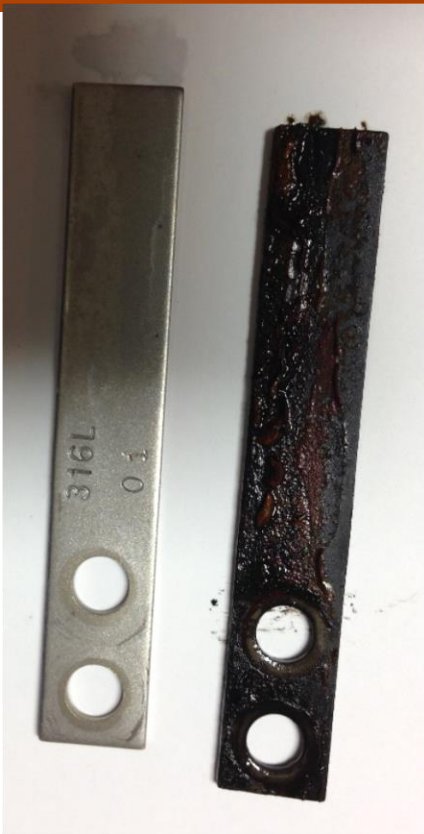
# SRP hot lean coupons. 340 hours H<sub>2</sub>O testing, 162 hours of operation w/ 5 m PZ, 150°C, $\alpha = 0.21$

mag 4 066 x det ETD spot 3.0 HV 30.00 kV WD 19.0 mm

Red Product:  
FeO(OH)

- Higher than expected C1010 corrosion in absorber
- 316L performance in hot, lean better than expected
- C1010 in hot, lean 5 m PZ
  - Sometimes forms tight, crystalline layer of  $\text{FeCO}_3$
  - Sometimes forms flakey layer of  $\text{FeO}(\text{OH})$  and  $\text{Fe}_3\text{O}_4$ , may have been caused by extended  $\text{H}_2\text{O}$  testing.
- C1010 in cold, rich 5 m PZ
  - Formed patchy, flakey layer of Fe and  $\text{FeO}(\text{OH})$
- Can we modify conditions so that we always form  $\text{FeCO}_3$  protective layer?

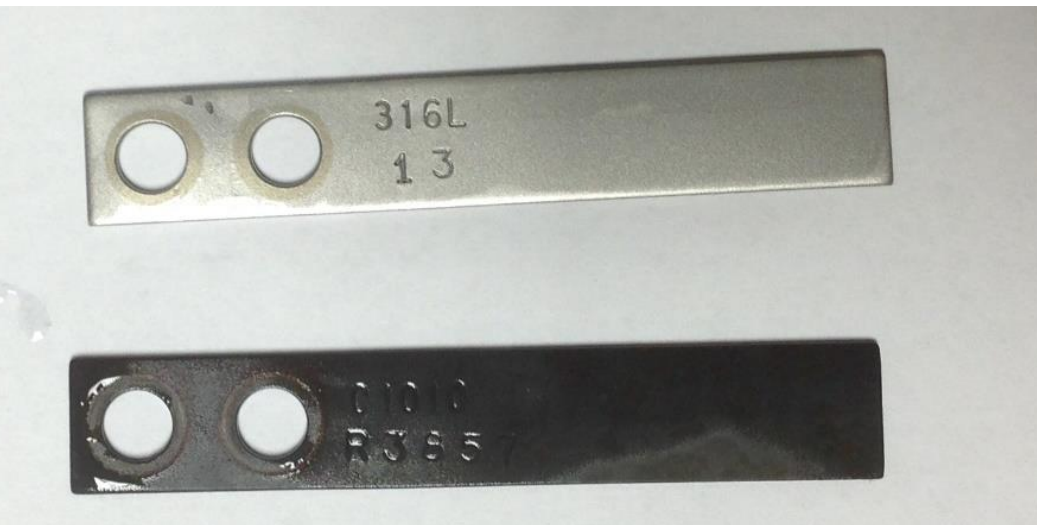
# SRP hot lean coupons. 134 hours operating operation w/ 5 m PZ, 150°C, $\alpha = 0.21$

Black Product:  $\text{FeCO}_3$  (Siderite)

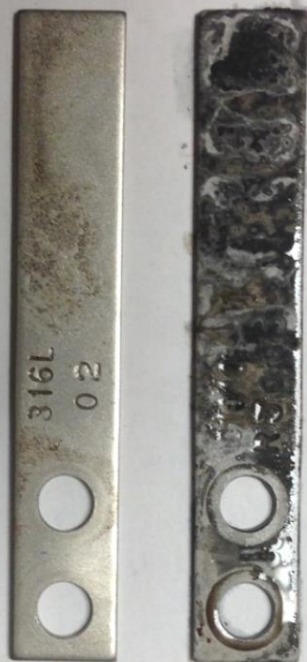
# SRP absorber. 340 hrs H<sub>2</sub>O testing. 392 hrs operating w/ 5 m PZ, 30°C, $\alpha = 0.33$

| mag | 3 536 x | det | ETD | spot | 3.0 | HV | 30.00 kV | WD | 19.6 mm |

20  $\mu$ m

Black Product: Fe

- Unexpectedly high absorber corrosion!
