JUICE RIME Antenna in-flight anomaly

J. Gumpinger, R. Le Letty, D. Monteiro, A. Atzei, D. Escolar

24/06/2024

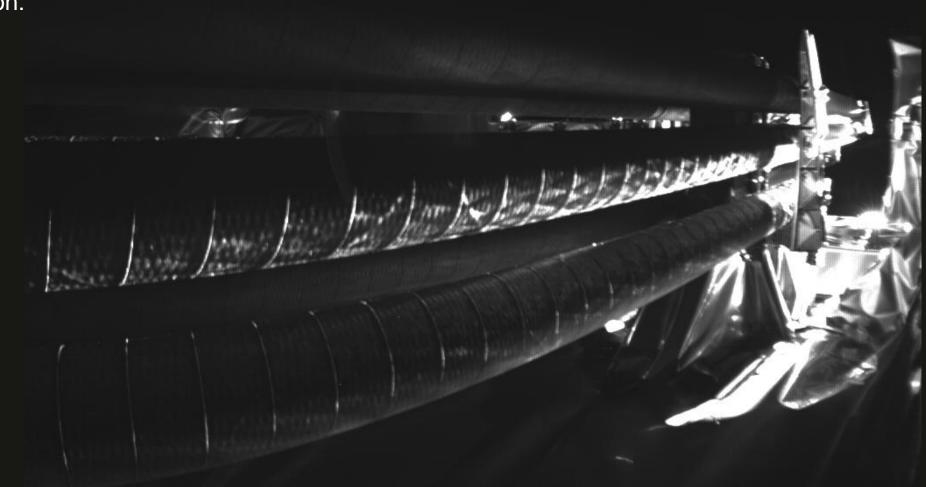
Nominal steps

NEA1 and 2 \rightarrow deployment of first segments on +Y and -Y booms T= -80C

After actuation:

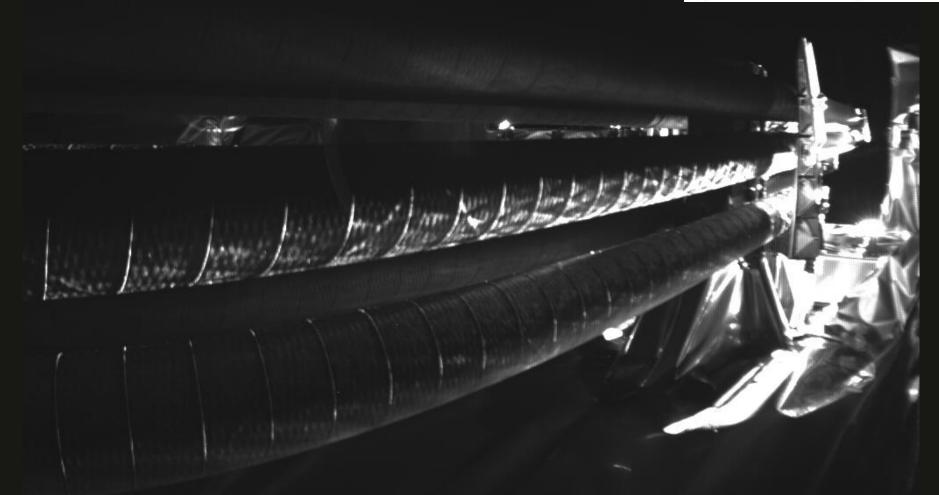
Nominal steps

NEA4 \rightarrow no deployment of +Y boom's second segment T= -80C

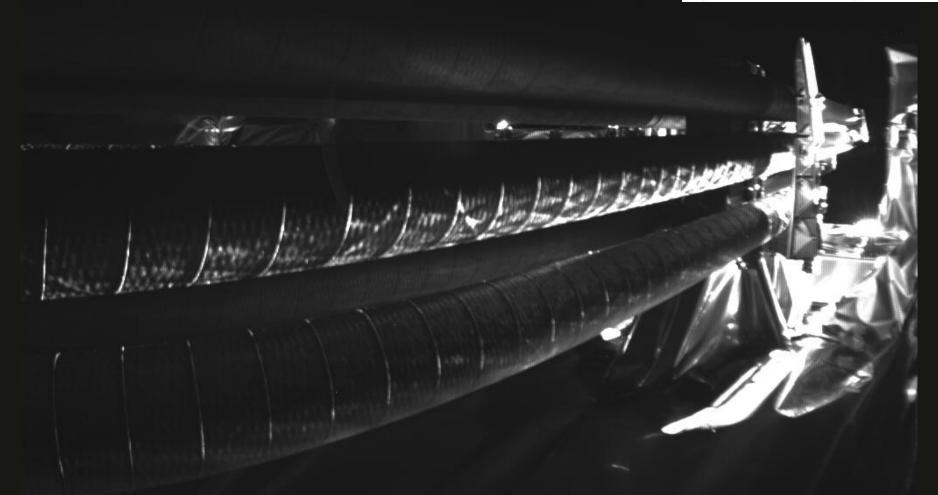
First attempt to recover

NEA5 \rightarrow no deployment of +Y boom's second segment T= -80C

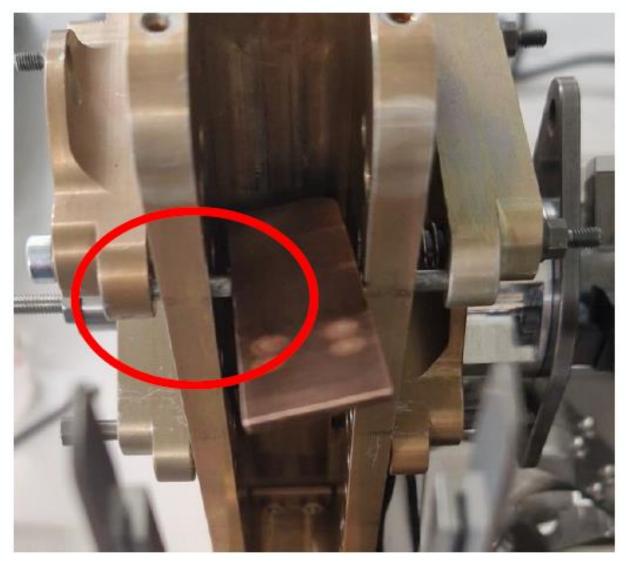
- Re-produced RC3: release spring failed to open
- Is believed to be due to a not fully retracted retainer pin
- Photo shows a simulation of this error on the EQM done at the supplier

- Most likely root cause in the initial RCA table was the boom being stuck in the HDRM (RC 4) → related onground NCR
- However, RC 3 could be reproduced on ground, this RC became more likely

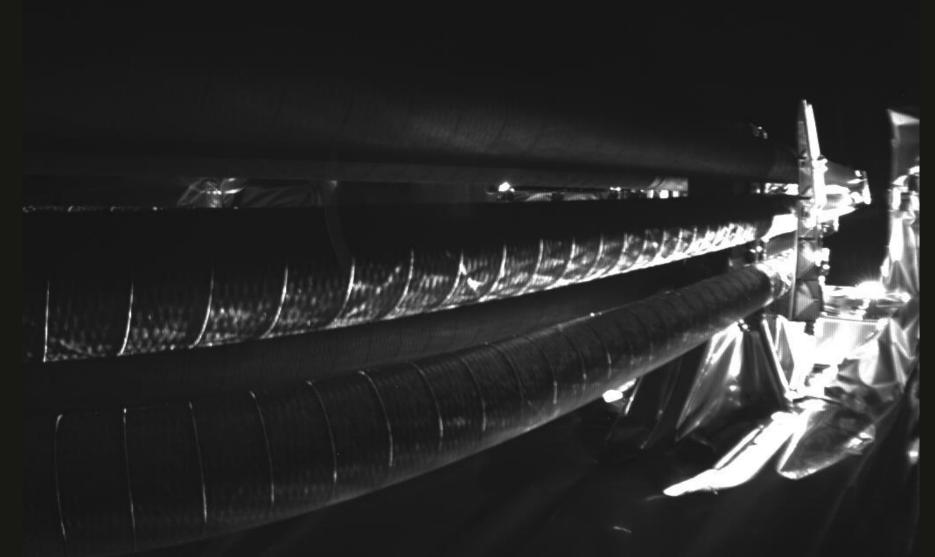
Attempts to recover

Slew of S/C to increase temperature to about -44C and Release of MagBoom \rightarrow no deployment

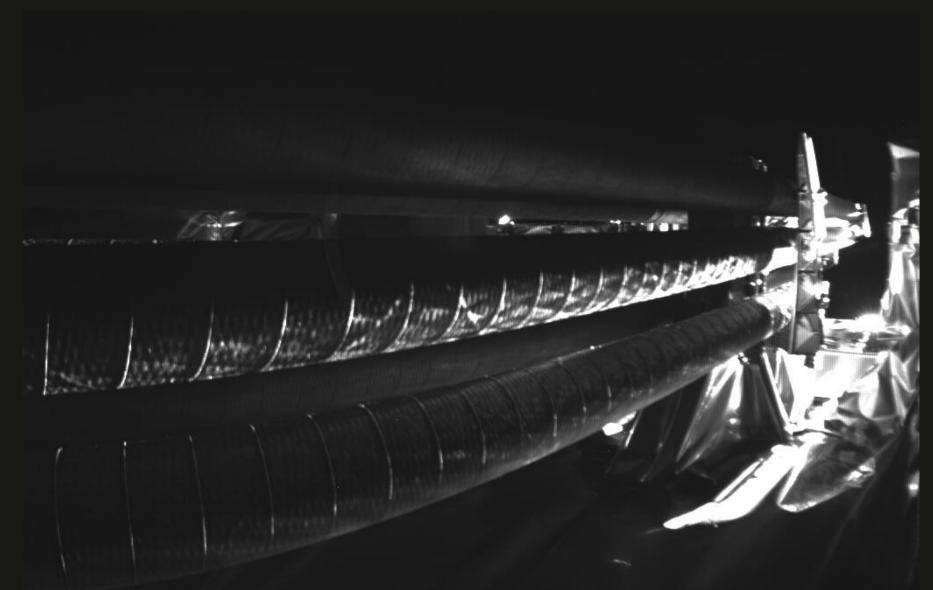
Attempts to recover

Main Engine Firing \rightarrow no deployment

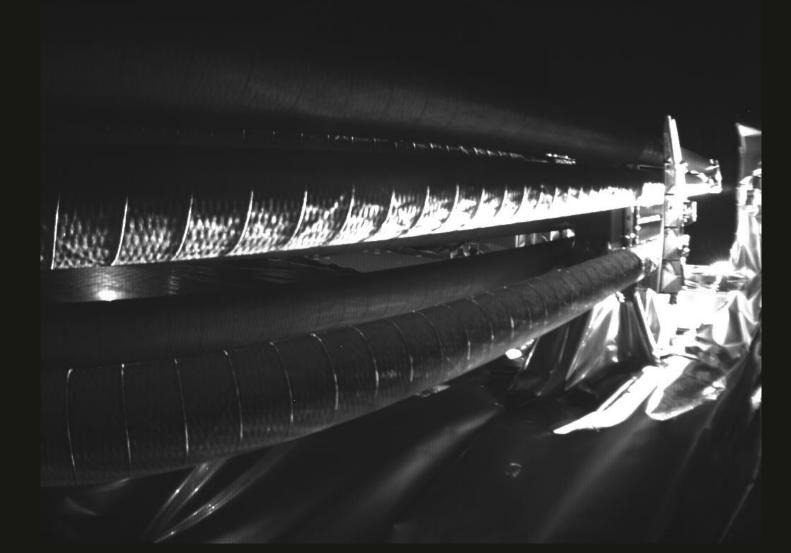
Slew of S/C to increase temperature to about ambient temperature and NEA6 \rightarrow deployment of +Y boom's second and third segment

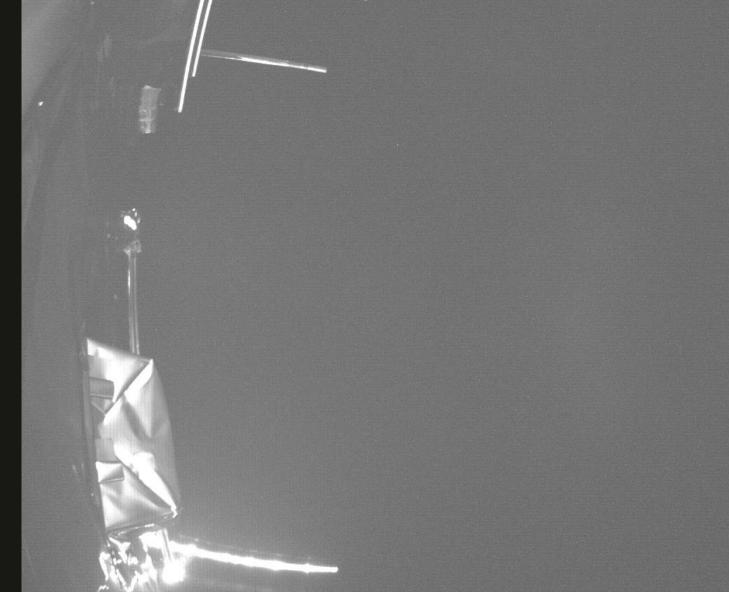
NEA6 \rightarrow deployment of +Y boom's second and third segment

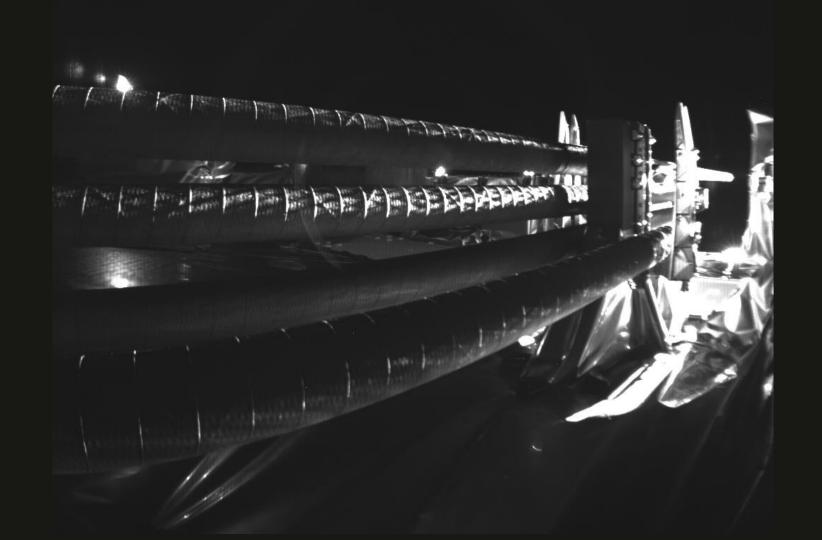
NEA3 \rightarrow deployment of -Y boom's second and third segment
