POST-MORTEM INVESTIGATION OF THERMAL DAMAGE IN CARBON/EPOXY COMPOSITE MATERIALS CAUSED BY SIMULATED LIGHTNING STRIKES

G. Zhou¹, A. Ashby¹, J. Golding¹, X. Bao² and W. Sun³

¹Department of Aeronautical and Automotive Engineering, Loughborough University, Leicestershire,
LE11 3TU, UK

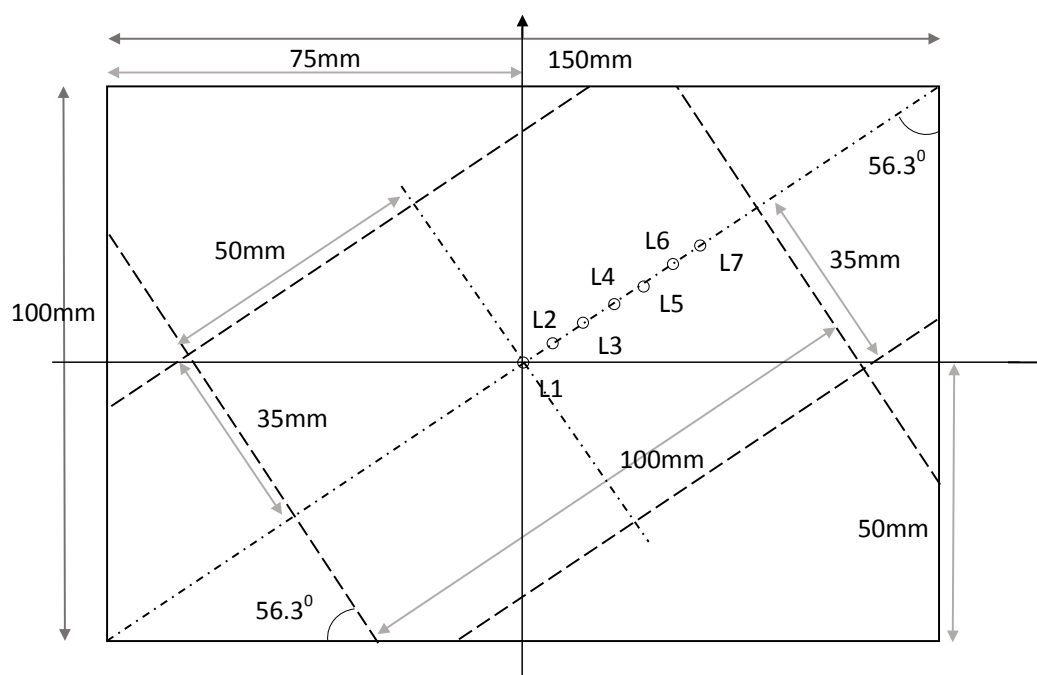
Figure 7. Locations of TGA samples extracted out of a lightning struck carbon/epoxy panel.

After SEM-EDS and FTIR-ATR examinations, the lightning struck panels were cut up and TGA samples of about 48 mg each were extracted from seven selected locations (circles on the diagonal line with the 6 mm centre-to-centre distance), as illustrated in Fig. 7. The reason that the relatively larger sample weight was used was controlled by the choice of the in-plane dimensions of 3 mm by 3 mm so as for test results to be representative. The L1-L2 locations (i.e. L1 and L2) are from the so-called central region, which was damaged by the lightning strike in all the panels, whereas the L6 and L7 locations were from the pristine region, which was undamaged even on the most damaged panel. The L3-L5 locations were from the ‘border’ region, which was dependent on the severity of the damage.
