Pipeline Integrity Data: An Essential Asset

Gabriel Pizani MIEAust CPEng RPEQ Principal Pipeline Engineer - OSD APGA Convention 2021

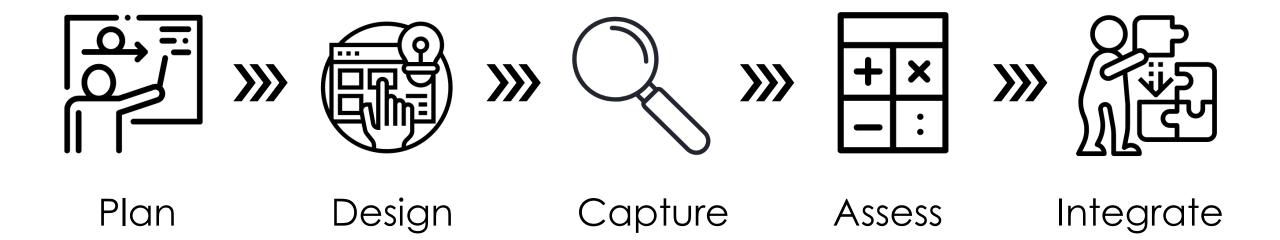
The Integrity Data Collection Process

- It is critical that integrity engineers, as well as operations personnel and management, are aware of the activities and frequencies outlined in the IMP
- IMP activities generate key inputs which, if not fed into the budget cycle promptly, an opportunity to make the appropriate corrections could be missed
- A strong governance system embedded in the PMS is often key to ensuring any deficiencies are addressed in time
- Multi-year plan is often developed, approved and funded for execution.
- A schedule should also be developed in parallel with the budget so that once funds are allocated, the program can begin without delay.
