## **EFFECT OF LASER SURFACE TREATMENT ON THE ADHESIVE PROPERTIES OF BONDED CFRP JOINTS**

**Keywords:** composite repair, fatigue, scarf patch, 1060 nm laser, aerospace

In this work, the effect of an Ytterbium fibre laser treatment on the adhesive properties of scarf bonded carbon fibre reinforced plastics (CFRP) joints has been investigated. The surfaces were scarfed and afterwards laser treated. The effect of laser treatment on the surface morphology was investigated with scanning electron microscopy (SEM) and X-ray photoelectron spectroscopy (XPS). The laser treatment resulted in a morphological and chemical change on the CFRP surface. The introduced thermal energy was able to partly strip and roughen up the carbon fibres. The laser treatment increased the carbon and decreased the oxygen, nitrogen and sulphur content on the surface. With the laser treatment the static and fatigue strength of the scarf bonded joints could be improved.

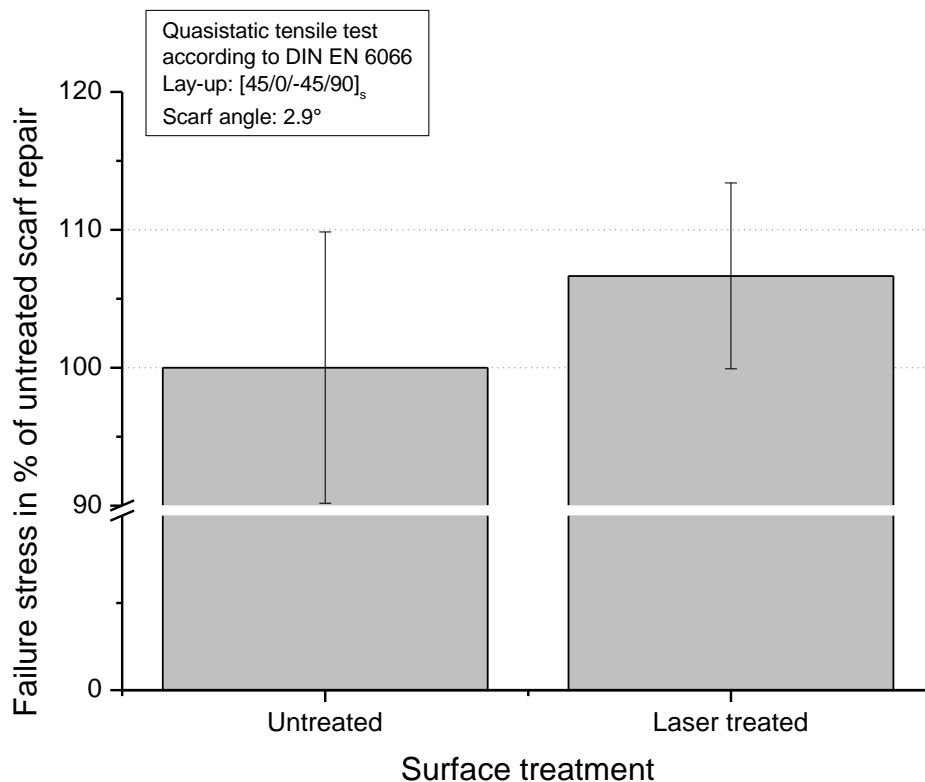
Figure 4 shows the results of the investigation of the static strength. The laser treatment improves the bonding strength by 7 %, though the difference lies within the experimental scatter. The tested specimens indicated a failure in the bond line and inter-fibre failure in the 90°-layer. Taking into account the results from the SEM and XPS investigation several mechanisms can be attributed to the improvement of the bonding strength.

One possible mechanism is the increase of the surface area due to the fibre stripping. This is accompanied by a deeper penetration of the adhesive and therefore mechanical interlocking is possible. As a roughening of the fibres could also be detected in the SEM, a surface increase can take place on a smaller scale than mentioned before and further contribute to the improved adhesion. While no functionalisation could be detected in XPS, it is possible that it overlaps with the decreasing epoxy resin ratio on the surface. Another explanation is that no functionalisation of the fibres takes place and the improvement is only due to the surface enlargement.

**Figure 4.** Failure stress in % of the untreated scarf repair for untreated and laser treated surfaces.

The Ytterbium fibre laser treatment was able to improve the static strength and fatigue performance of the scarf bonded repair. The static strength could be improved by 7 % while the maximum performance stress of the stress-cycle curve was around 8 % higher at  $10^5$  cycles for the laser treated surface.
