# DURABILITY OF COMPOSITE MATERIALS IN DEPLOYABLE STRUCTURES FOR SPACE APPLICATIONS

**Keywords:** Deployable structures; Composites; Space environment; Atomic oxygen; Space materials

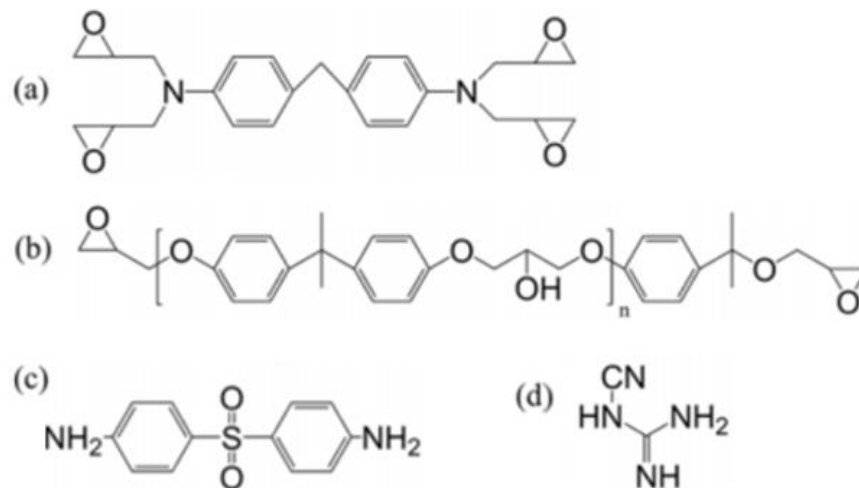
The chemical structures of these materials are shown in Figure 1. LAM 01 uses a resin system which contains (a) triglycidyl-4,4'-diaminodiphenylmethane (TGDDM) cured by (c) diaminodiphenylsulfone (DDS). LAM 02 and LAM 03 use the same resin system which is formulated from a blend of two epoxy resins: (a) TGDDM and (b) bisphenol A diglycidyl ether (DGEBA), cured with (d) dicyandiamide (DICY).

**Figure 1.** Chemical structures of epoxy resin A: (a) TGDDM cured with (c) DDS and epoxy resin B: (a) TGDDM and (b) DGEBA blend cured with (d) DICY <sup>[10]</sup>.

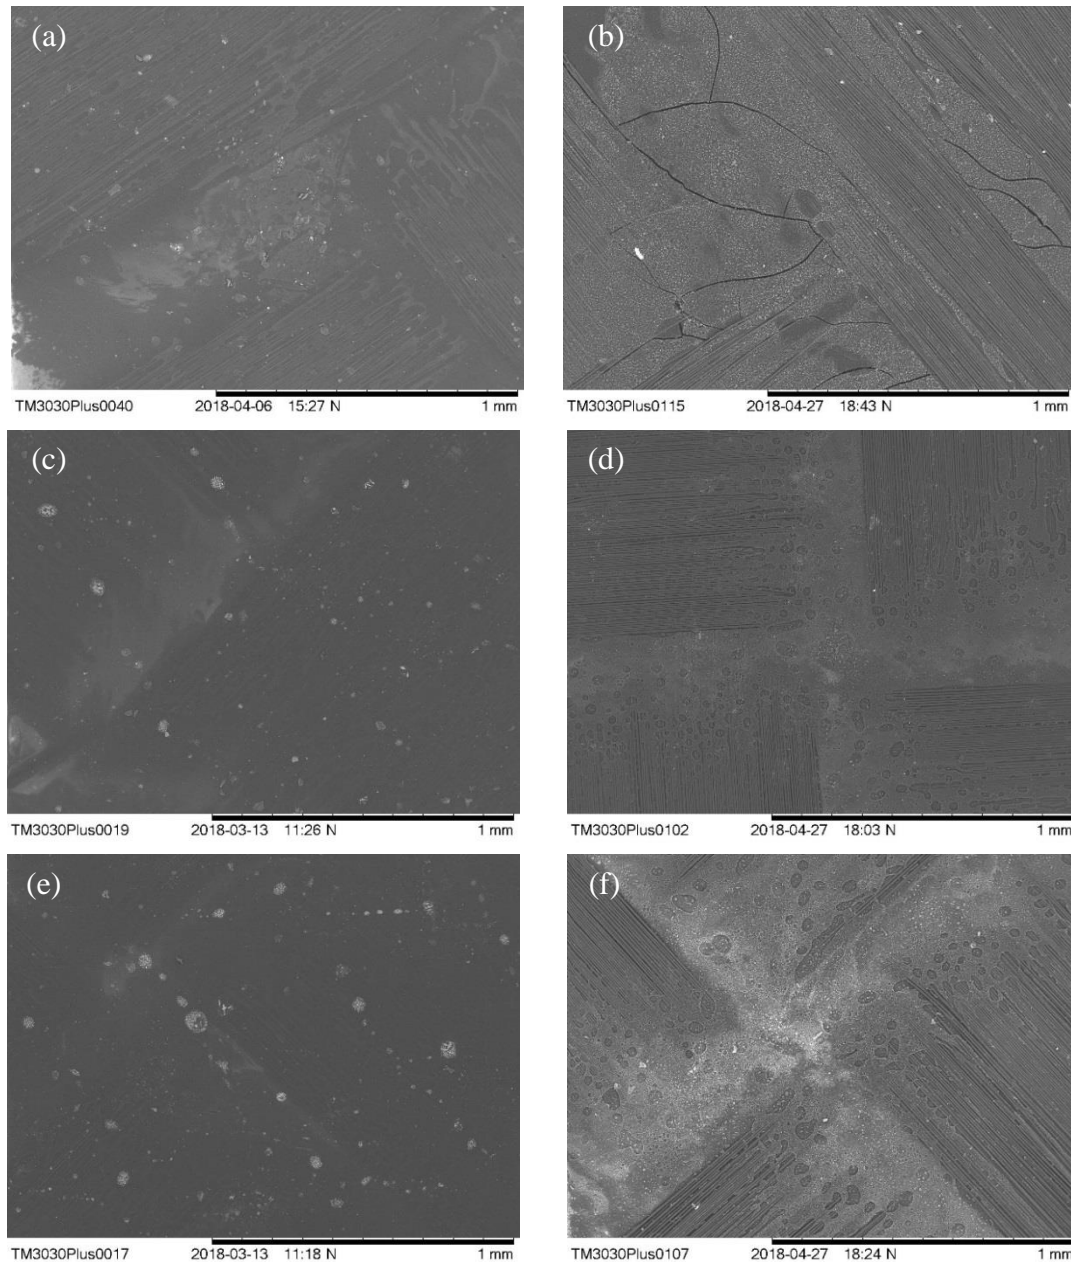
Before AO exposure, no obvious defects were detected on the surface of three laminates (Figure 2 (a), (c), and (e)). After the third exposure, when all samples had received the highest total AO fluence, the

surface resin had been severely eroded from all the laminates, exposing the fibres underneath to the AO (Figure 2 (b), (d), and (f)). Several erosion holes can be observed on the residual resin which is located in the gaps and at the edges between the warp and weft of the carbon fibre yarns in each laminate. These holes indicate that the erosion due to AO is not even, and it occurs at weaker points in the resin (*e.g.* at structural moieties which are more susceptible to attack such as hydrogen atoms bonded to alkyl fragments) and provides a path for AO to erode the underlying resin still further.

**Figure 2.** The surface morphologies of the LAM 01 (a, b), LAM 02 (c, d) and LAM 03 (e, f) before and after third exposure (a, c, e, AO fluence = 0; b, d, f, AO fluence =  $3.82 \times 10^{20}$  atom/cm<sup>2</sup>).

In addition to the resin erosion, it is also noticeable that the resin in the gaps between the fabric yarn in LAM 01 displays significant cracks after AO exposure (Figure 2 (b)), which are not present in either LAM 02 or LAM 03. The cause of this cracking is not yet known and requires further analysis.

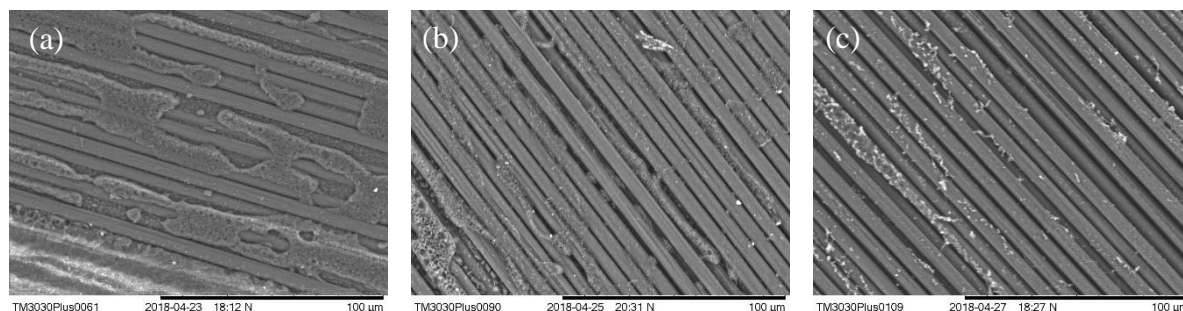
Figure 3 shows a gradual erosion of the surface resin for LAM 03. After the first exposure, resin was significantly eroded, and part of the underneath carbon fibres are exposed with the erosion of resin. The

resin was further eroded in the second exposure, while in the third exposure the surface resin had been almost completely eroded.

**Figure 3.** The surface morphology change of the LAM 03 after (a) first exposure, (b) second exposure, and (c) third exposure.

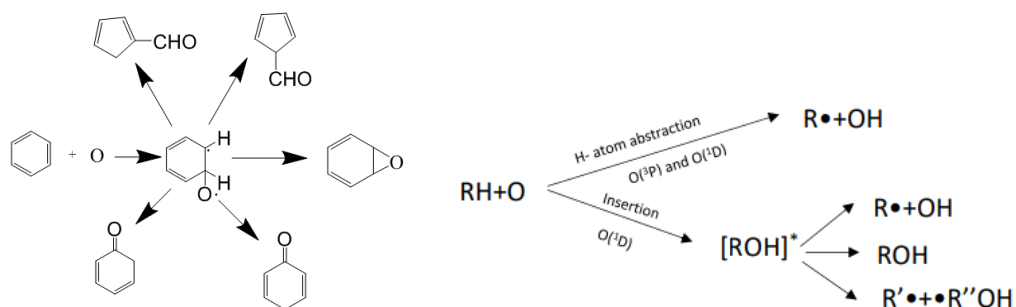
The reaction between the polymer matrices and AO is complex and depends on the chemical structures. In our work, the principal reaction with AO is believed to be through a biphenyl segment containing a saturated alkyl bridge within the chemical structure of the epoxy. The reactions take place between the polymer and two kinds of AO: the ground state (3P) and electronically-excited (1D)<sup>[14]</sup>. The ground state O (3P) can abstract a hydrogen atom in the polymer structure to form a hydroxyl group with a reaction barrier of 28.9, 18.8, and 13.8 kJ/mol. (where the abstracted H is primary, secondary, and tertiary, respectively)<sup>[14]</sup>. The O (1D) can also react with the polymer by abstracting a hydrogen atom, but it is more likely to undergo insertion into the C-H bond of a polymer with no barrier. A summary of the possible reactions is shown in Figure 4. During the reaction, volatile fragments, such as short-chain oxidation products, may leave the surface and thus degrade the performance of the materials.

**Figure 4.** The mechanism of the reaction between the polymer matrix and AO<sup>[14,15]</sup>

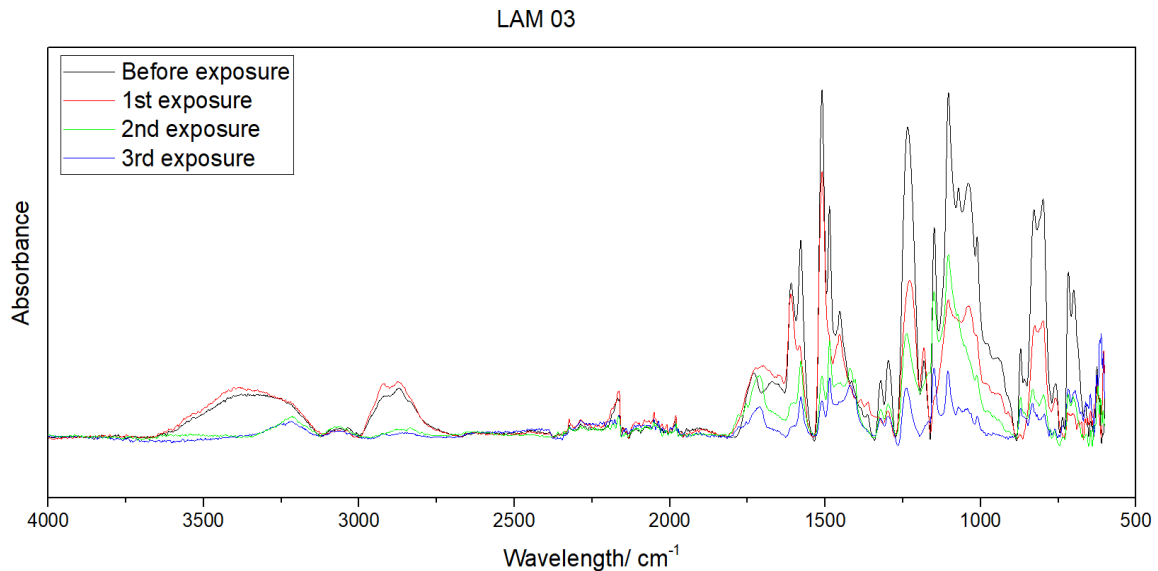
The results of FTIR spectral analysis of LAM 03 as it undergoes exposure to the AO flux are shown in Figure 5 as a representative example. A gradual decrease in the intensity of the spectral bands can be observed in all the laminates with the increase of AO fluence. A common change within the three laminates after exposure is that the centre of the hydroxyl stretching vibration at around 3400 cm<sup>-1</sup> shifts to lower frequency (3250 cm<sup>-1</sup>), suggesting the loss of free O-H stretch and finally vanishes due to the reaction between AO and hydroxyl. The decrease in the intensity of the other bands also indicate the loss of the matrix from the surface of the laminates: after the first exposure, a slight reduction of intensity can be detected, which indicates that a significant amount of resin remains on the surface. However, after the second and third exposures, the intensity of the bands decreases rapidly, with only several bands (due primarily to the carbon fibres) detected after the third exposure, which is consistent with the SEM data.

**Figure 5.** FTIR spectra of LAM 03 as a function of AO fluence exposure.

- (2) The results of FTIR spectral analysis suggest that the surface resin on all laminates has suffered significant degradation after exposure. After the third exposure, the spectra are principally due to the carbon fibres, with only a weak characteristic peak for the resin was observed in all laminates.

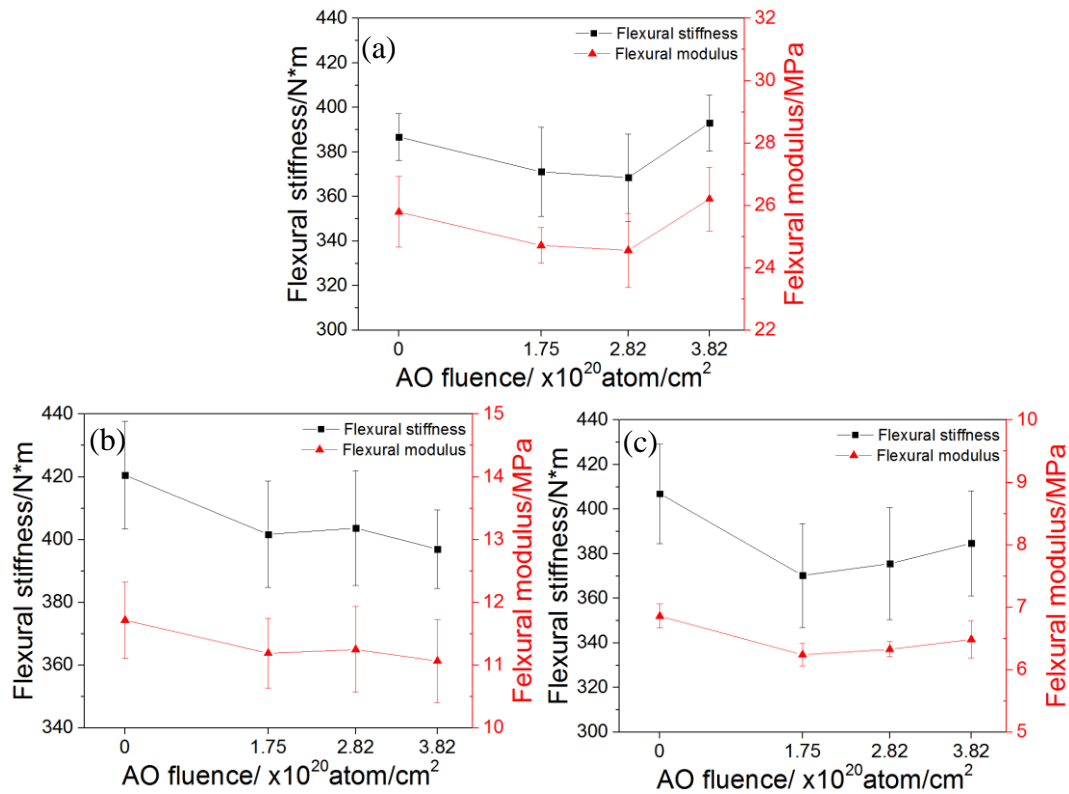
Table 3 shows the dimension of samples been tested and the results of the 3-point bending measurements for each laminate under different AO fluence are shown in Figure 6. There is a reduction of 5-10% in both the flexural rigidity and modulus of all laminates after the first exposure due to the erosion of resin, and a general downward trend thereafter. The SEM results in the previous section suggest that a significant amount of surface resin has been removed, exposing fibres after the first cycle. According to the in-orbit data from MISSE<sup>[10]</sup>, the erosion yield of epoxy is about 10 times greater than that recorded for pyrolytic graphite (a model for the carbon fibres). Thus, after the majority of the resin has been eroded, the exposed carbon fibre is relatively resistant to erosion, although not entirely inert. Therefore, after the first exposure, the flexural properties will not change significantly unless the fibres become seriously eroded and damaged, which requires a high AO fluence.

LAM 01 displays an increase in the flexural modulus after the third exposure, which is consistent with the work of Paillous *et al.*<sup>[16]</sup>, who reported that at the beginning of exposure, the erosion of the outer surface of resin results in a slight increase in fibre content, while the work of NASA's Long Duration Exposure Facility (LDEF)<sup>[17]</sup> has also demonstrated that flexural properties are sensitive to surface degradation. In the present work, the fibre content and surface conditions are likely more important variables than the graphite fibre type or epoxy matrix type in determining the susceptibility of carbon fibre reinforced epoxy composites to AO erosion. However, this does not explain why LAM 02 and LAM 03 did not experience an increase in flexural properties after exposure under the same conditions. In addition, the flexural rigidity of LAM 01 also increased after exposure, further study is needed to account for this.

**Figure 6.** Flexural properties of (a) LAM 01, (b) LAM 02, and (c) LAM 03 as a function of AO fluence exposure.

- (3) The mechanical tests suggest that the flexural properties of all laminates degrade significantly after the first exposure due to the erosion of matrix. LAM 02 and LAM 03 show a slight variation in their flexural properties after the second and third exposures. The flexural properties of LAM 01 show an unexpected increase after the third exposure, and further study is needed to understand this mechanism.
