# EXPERIMENTAL STUDY OF COMPOSITE STRUCTURES REPAIRS USING ADDITIVE MANUFACTURING TECHNOLOGIES

## Abstract

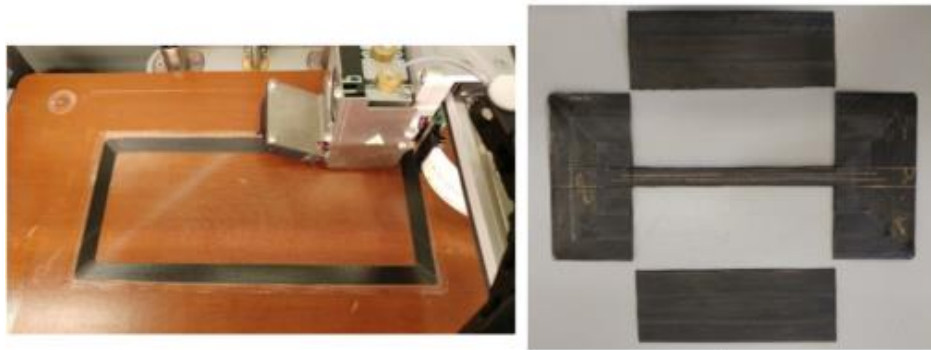
**Figure 4. Carbon fiber patch manufacturing**

Fiberglass patches and carbon fiber patches were manufactured. The fiberglass patches have a 0° and 90° orientation and those of carbon only 90° orientation. Some limitations appeared during the manufacturing process of the carbon fiber patch. It was found that the orientation of the fiber can not be customized, as the deposition of the fiber is done circumferentially and in the central zone includes nylon [8]. The part model geometry introduced in the printing software has to fit into this constrain. To obtain a patch of this material, the panel that can be printed must be machined, as shown in Figure 4. In this way, the carbon fiber patch is obtained in two parts that will later be bonded together.

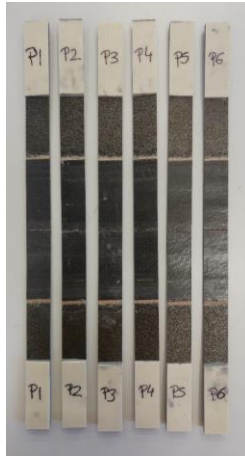
**Figure 5.** Conf1 Carbon fiber\_90° (film adhesive)

The bonding of the specimens were carried out as secondary bonding, i.e., both the base and the patch material were cured before bonding. In order to improve the joint, the adherents were previously sanded. Film adhesive was cured at 120°C, since two phase adhesive was cured at 60°C. The bonding of the fiberglass patches lacked complexity, not occurring this way for carbon fiber patches, where it was necessary to take special care in the alignment since they were formed by two halves. For all configurations, tabs were bonded by adhesive redux with the purpose of promoting valid failure modes on the central areas of the specimens.

The different configurations of repaired panels are shown in Figure 5 - Figure 10.

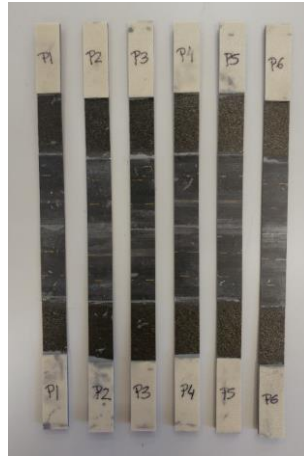
**Figure 6.** Conf2 Carbon fiber\_0° (two phases adhesive)

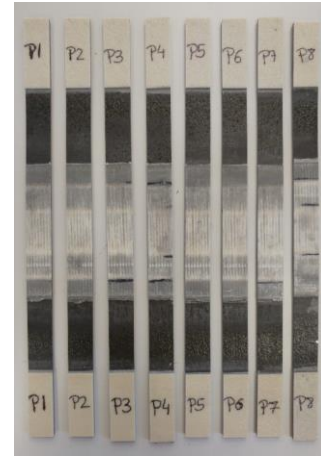
**Figure 7.** Conf3 Fiberglass\_0° (two phases adhesive)

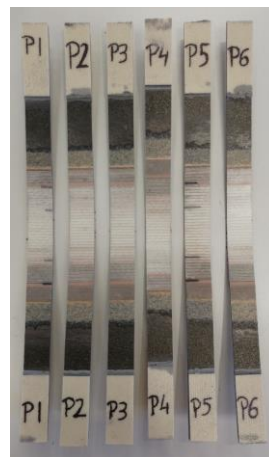
**Figure 9.** Conf5 Fiberglass\_90° (film adhesive)

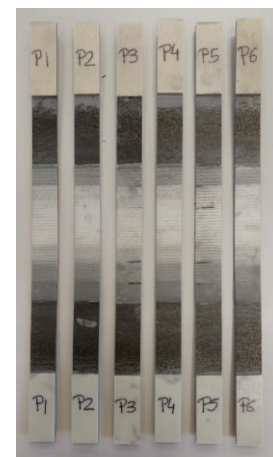
**Figure 10.** Conf6 Fiberglass\_90° (two phases adhesive)

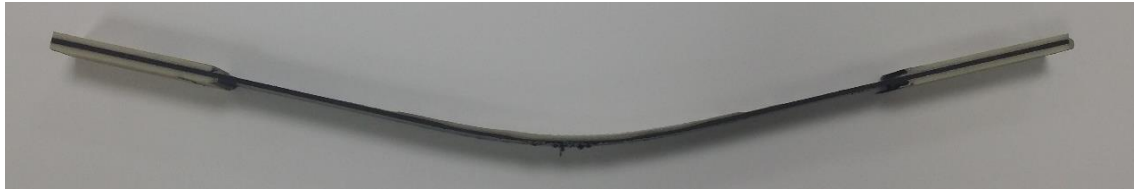
**Figure 11.** Excessive curvature in Fiberglass patch at 90°

The manufactured specimens can be divided into two main groups: those whose repair has been manufactured with fiberglass and those that have been repaired with carbon fiber. In the case of fiberglass, there are two orientations of the repair fibers (0° and 90°). However, only the test specimens with 0° repair patch are tested because the specimens manufactured with 90° orientation presented a significant curvature (see Figure 11), as a result of the residual stresses to which the fibers were subjected during path curing. These residual stresses are caused by the joining of two different materials with different thermal expansion coefficients in a curing process that involves high temperatures. Two types of different adhesives have been used, and 5 repaired specimens of each series were extracted and tested.

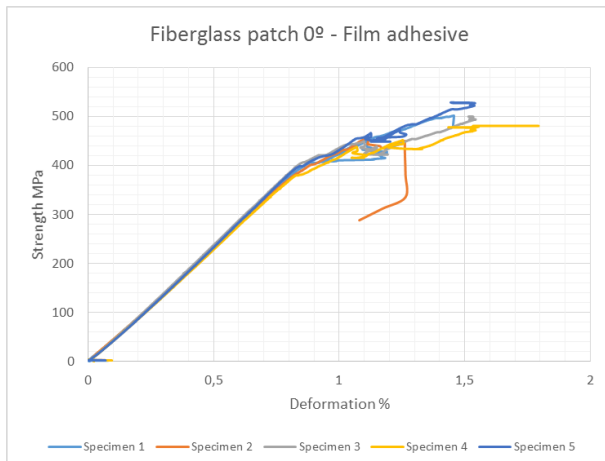
**Figure 12.** Fiberglass patch 0° - Film adhesive

The test results obtained during the test campaign are shown in Figure 12 - Figure 15. A higher tensile strength can be observed in specimens repaired with film adhesive, due to the fact that a film adhesive achieves a better distribution of stresses throughout the patch. On the other hand, elastic moduli are similar for each type of patch (fiberglass and carbon fiber), since this property is mainly controlled by the substrate panel, equal in both cases.

Initially, fiberglass patches curves present a linear evolution until the patch contribution appears, where the specimen leaves its linear behavior. In the case of carbon fiber patches, curves only present a linear evolution up to failure, due to the fact that the stacking sequence of specimen is equal to 90°, and the resin is the most important factor associated with the tensile strength.

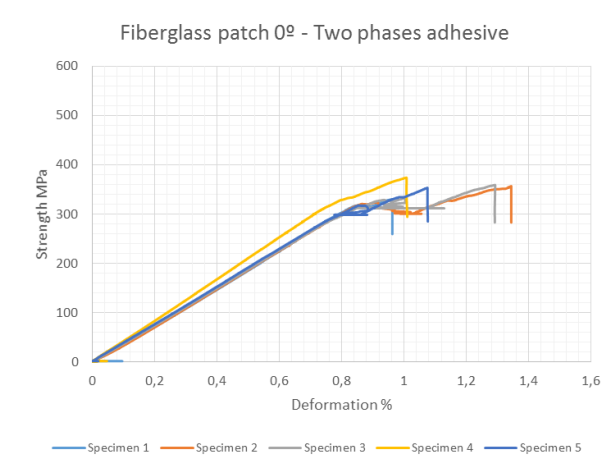
**Figure 13.** Fiberglass patch 0° - Two phases adhesive

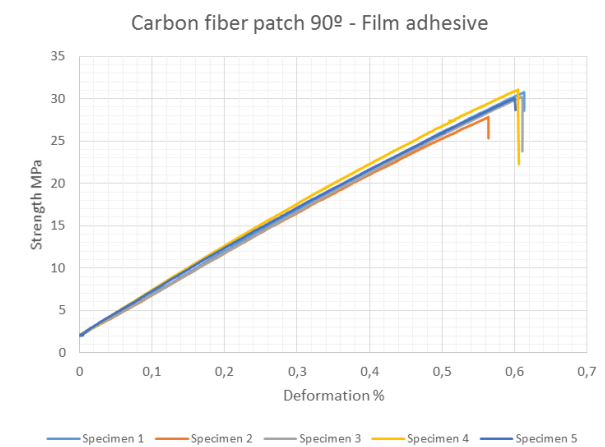
**Figure 14.** Carbon fiber patch 90° - Film adhesive

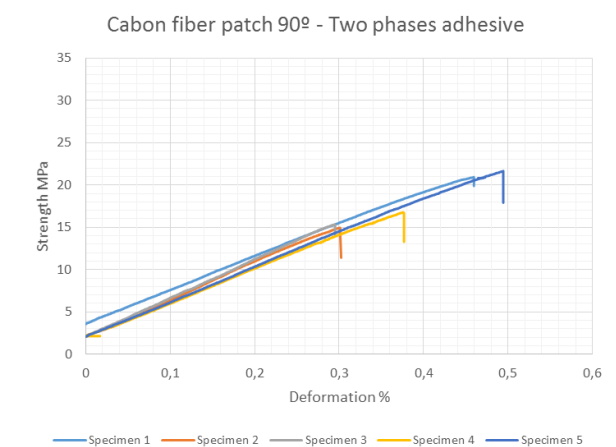
**Figure 15.** Carbon fiber patch 90° - Two phases adhesive
