OPTIMIZING COMPOSITE REPAIR TECHNIQS

S. Psarras¹, G. Sotiriadis¹, T. Loutas¹ and V. Kostopoulos¹

Keywords: Composites, Repairs, Laser, Optimization, Finite Elements

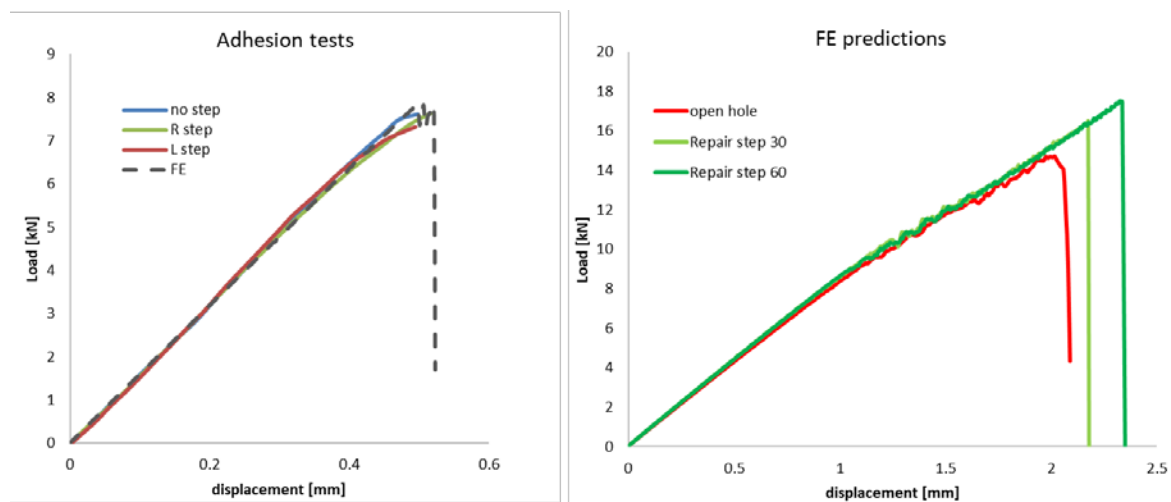
Figure 3. Left: two-step tensile tests are compared with FE model for adhesion modelling evaluation, Right: FE model predictions for open hole and repaired specimens

Two step specimens were tested in tension in order to evaluate the adhesion of the bonding. The test results were compared in detail against the numerical findings both at the level of stiffness and strength as can be seen on the left in Figure 3. The effectiveness of stepped repair to damaged fiber reinforced composite materials was investigated by using validated FE numerical models. Attention was given at the actual failure modes of composites including delaminations. All FE models took into account the anisotropy in each ply in the laminate and in the repair patch by splitting the laminates to sublaminates. This method was introduced in order to take into consideration the effect of delamination caused by the failure between the plies due to shear stresses. Parametric studies were carried out in order to compare forces, displacements, stresses and stiffness properties. Namely, models were analyzed depending on the overlap segment's length with repair scarf ratios varying from the value of 20 to the value 60 with a step increase of 10. The FE models allowed a direct comparison of the influence that the step length to ply thickness ratio had to the strength and stiffness restoration of the repaired composite structures, on the right in Figure 3, as well as at the level of full field developed strain around the repair patch at different loading stages. It seems that a repaired specimen with a 1/60 step ratio could increase by 20% the strength of the defective specimen.

At the modelling level, the developed models was fed with real damage data and evaluated the stiffness and strength degradation due to damage showing that a scarf ratio of 60 can increase by 20% the strength of the defective specimen. More results and details can be seen in the conference presentation.
